Investigation of a Notable Landslide under Complex Hydrogeological Conditions at Pak Tam Road, Sai Kung, Hong Kong

Kevin S. P. Lam^{1,*}, Michael R. Tracy²

SUBMITTED 25 November 2024 REVISED 16 December 2024 ACCEPTED 27 December 2024

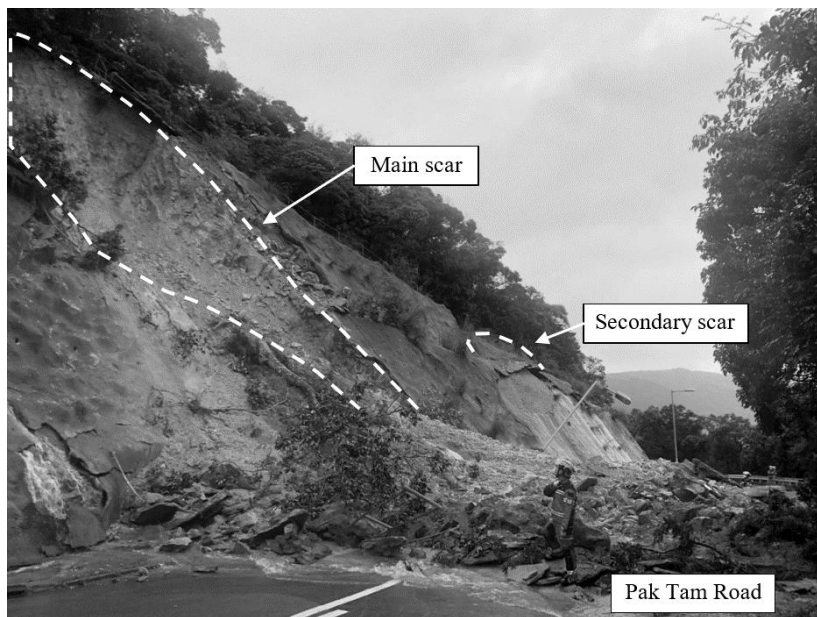
On 8 June 2022, around noon, a landslide occurred at the registered soil and rock cut slope (Feature No. 8NW-D/C5) adjoining Pak Tam Road in the Sai Kung East Country Park in Hong Kong, during an intense rainstorm (referred to as “the landslide” and “the slope”, respectively). The landslide involved two failures, including a main scar across the full height of the slope and a secondary scar on the upper slope batter nearby, resulting in a total failure volume of about 300 m³ (Figures 1 and 2). The landslide debris was deposited mainly on the carriageway of Pak Tam Road, leading to the temporary closure of the road for more than a week. This closure disrupted the lives of over 400 villagers in the northeast of Hong Kong who rely on the road for access to Hoi Hai Village and other local villages. The media widely reported the landslide and there were no casualties.

Figure 2. General view of the landslide

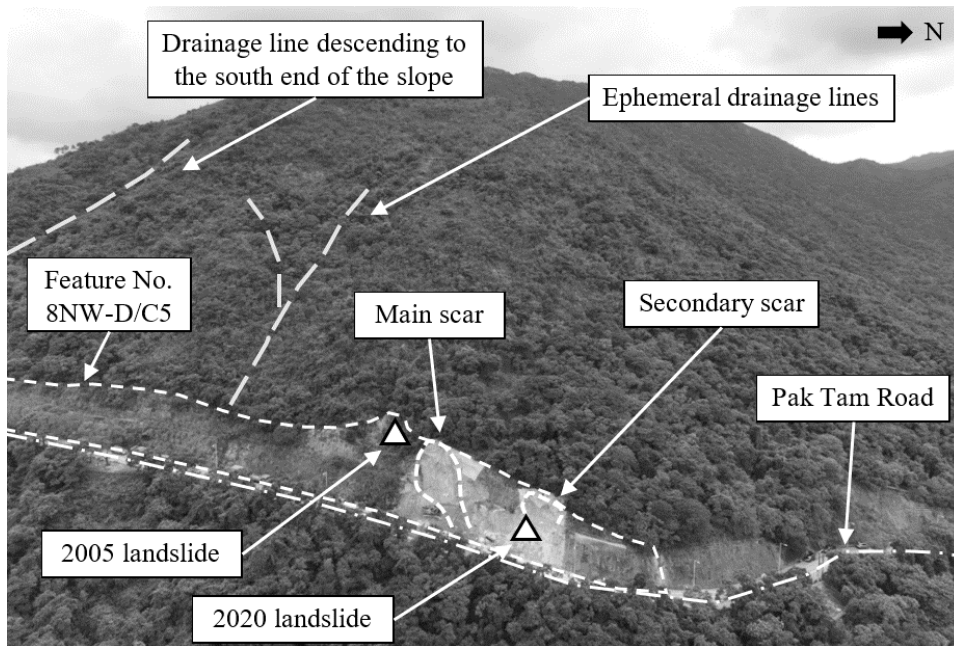
The landslide occurred on an east-facing slope with dimensions of about 300 m long, 20 m high and 50° inclined on average (Figure 3). The slope is mostly covered by shotcrete with occasional stone pitching cover and exposed rock outcrops. It has two batters and a surface drainage system comprising U-channels, stepped channels and downpipes at the crest, mid-slope and toe. Above the crest of the slope is a natural hillside with a gradient of about 28° , and at the toe of the slope is Pak Tam Road, a two-lane, two-way carriageway descending towards the north. No distinct drainage lines are descending to the landslide site, but within the natural hillside above the slope, a major drainage line descends at the south end of the slope, and a pair of ephemeral drainage lines converge at about 250 m and 75 m, respectively, to the south of the landslide site.

Figure 3. Aerial view of the slope

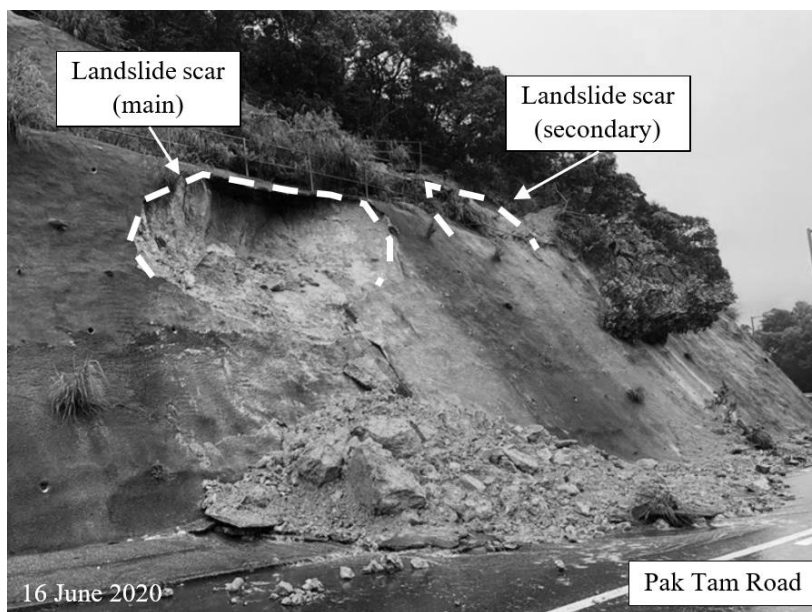
The earliest aerial photographs taken in 1945 show that the area where the landslide occurred was mostly a natural hillside with light to moderate vegetation. The slope was formed between 1964 and 1974 in relation to the construction of Pak Tam Road and was largely completed by 1975. There were two landslides reported in 2005 and 2020, respectively. The 2005 landslide occurred on the natural hillside just above the crest of the slope and had a failure volume of about 20 m³. The 2020 landslide involved two failure scars in the northern portion of the slope with a failure volume of about 17 m³ (Figure 4). The main scar was right below the slope berm, while the secondary scar was situated on the upper slope batter, coinciding with the secondary scar of the 2022 landslide. These landslide scars were later repaired by applying shotcrete with weep holes.

Figure 4. Landslide in 2020

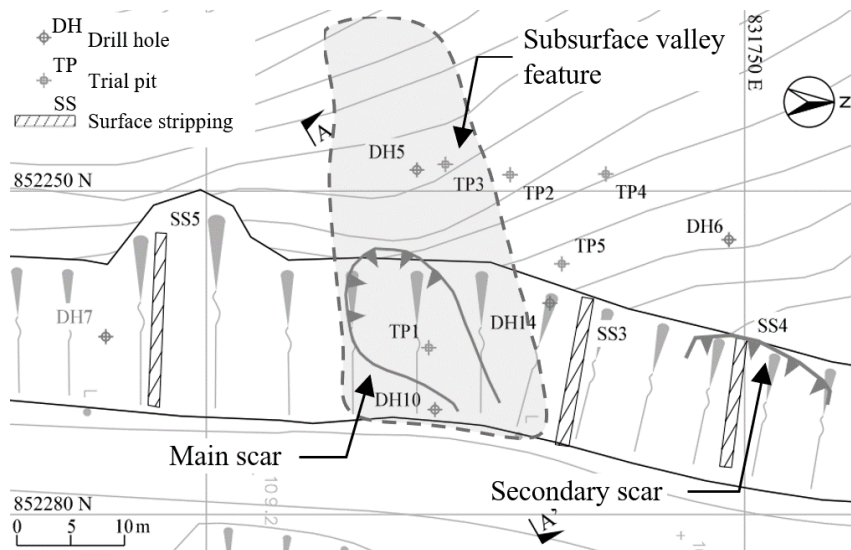
Site-specific ground investigation reveals that the geology of the landslide site is primarily composed of weathered tuff overlain by a mantle of colluvium. The colluvium layer was up to 2 m thick and consisted of angular to sub-angular fine to coarse gravel and cobble- to boulder-sized rock fragments. Beneath the colluvium layer, there was a 9-m-thick layer of saprolitic soil, which comprised completely to highly decomposed coarse ash crystal tuff (C/HDT) and highly to moderately decomposed coarse ash crystal tuff (H/MDT) towards the base of the unit. This formed a less permeable layer to the strata of colluvium and C/HDT above. Bedrock, which was moderately to slightly decomposed coarse ash crystal tuff (M/SDT), was found at various depths ranging from 4 m to 11 m below the ground level. A depressed rockhead surface was encountered in drill hole Nos. DH5 and DH10, forming a subsurface valley feature (Figure 5).

Figure 5. Subsurface valley feature

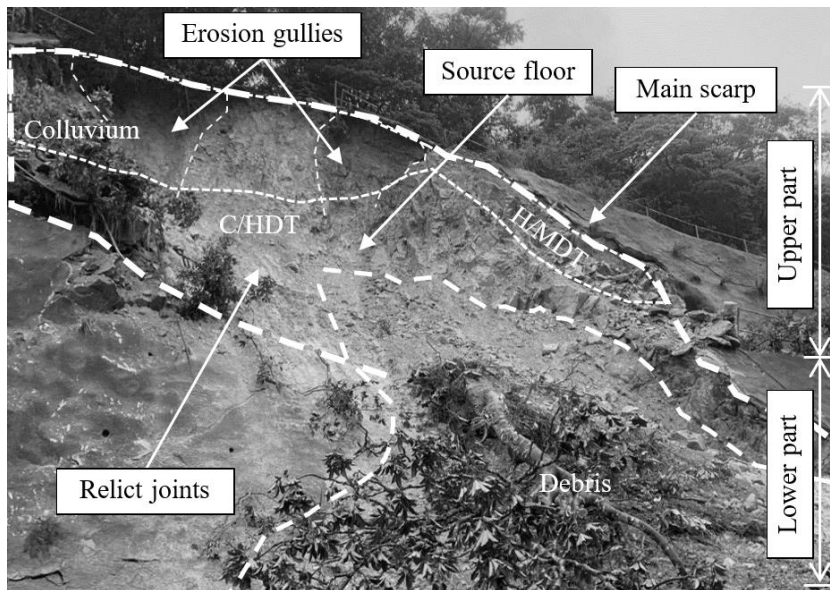
The main scar involved the full height of the slope and could be divided into upper and lower parts (Figure 6). The upper part was spoon-shaped and about 10.5 m wide, 15 m long, and up to 2.5 m deep. It encroached onto the natural hillside above and straddled across the intermediate slope berm. The lower part of the main scar was an extension of the upper part, but with a shallower extent. It was rectangular-shaped and about 4.7 m wide, 9.4 m long and 1.7 m deep. The main scarp was steeply inclined at about 75° with two discrete erosion gullies. The source floor was inclined at about 40° to 50° dipping out of the slope. The exposed colluvium, forming much of the main scarp, comprised angular gravel and cobble, and occasional cobble- to boulder-sized rock fragments within a silty sand matrix. Below the colluvium was a layer of C/HDT, comprising stiff to hard sandy, clayey silt with blocks of H/MDT. The source floor exposed adversely orientated relict joints on C/HDT, partly forming the basal slip plane, dipping between 25° to 50° out of the slope.

Figure 6. Main scar

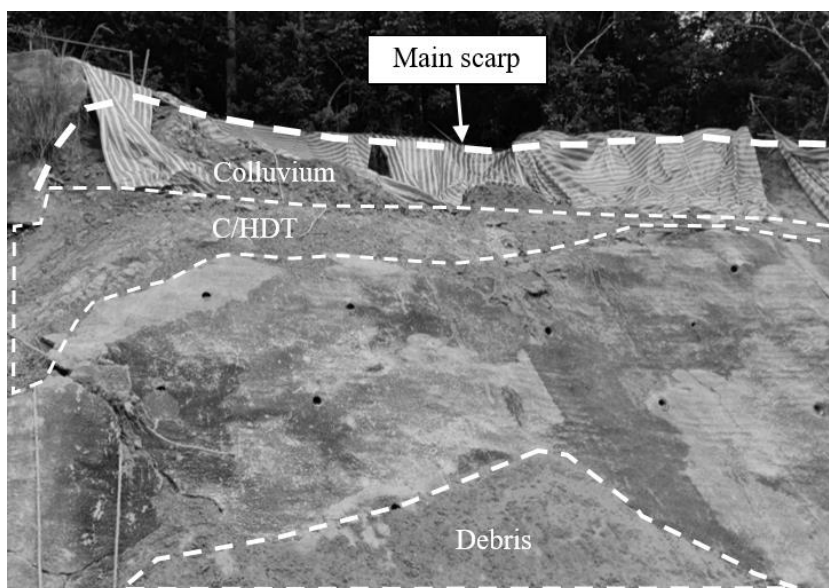
The secondary scar was located approximately 20 m north of the main scar and involved a re-activated failure of the previous landslide in 2020 (Figure 7). The landslide was shallow with limited movement of the displaced shotcrete cover. The scar had a rectangular shape of about 12.5 m wide, 7.5 m long and 0.5 m deep. Colluvium formed the main scarp and C/HDT formed the source floor. The material characteristics of colluvium and C/HDT were similar to those described in the main scar, although no relict joints were observed on the source floor.

Figure 7. Secondary scar

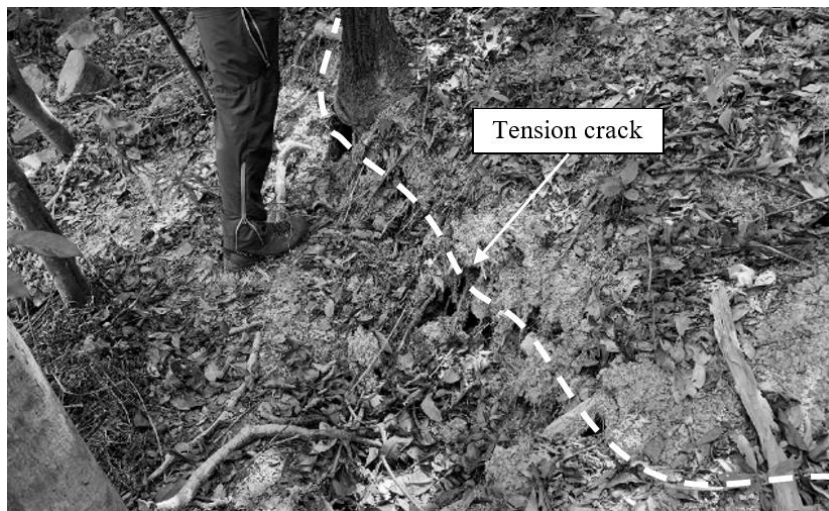
Tension cracks were observed above the landslide scars and generally orientated in a northwestern to southeastern direction. The tension cracks were measured to be about 3 m to 12 m long with a vertical displacement of up to 0.2 m, exposing colluvium (Figure 8). The growth of moss and the general weathered appearance of the exposed soil surface suggest that part of the tension cracks was formed before the landslide.

Figure 8. Tension cracks above the landslide scars

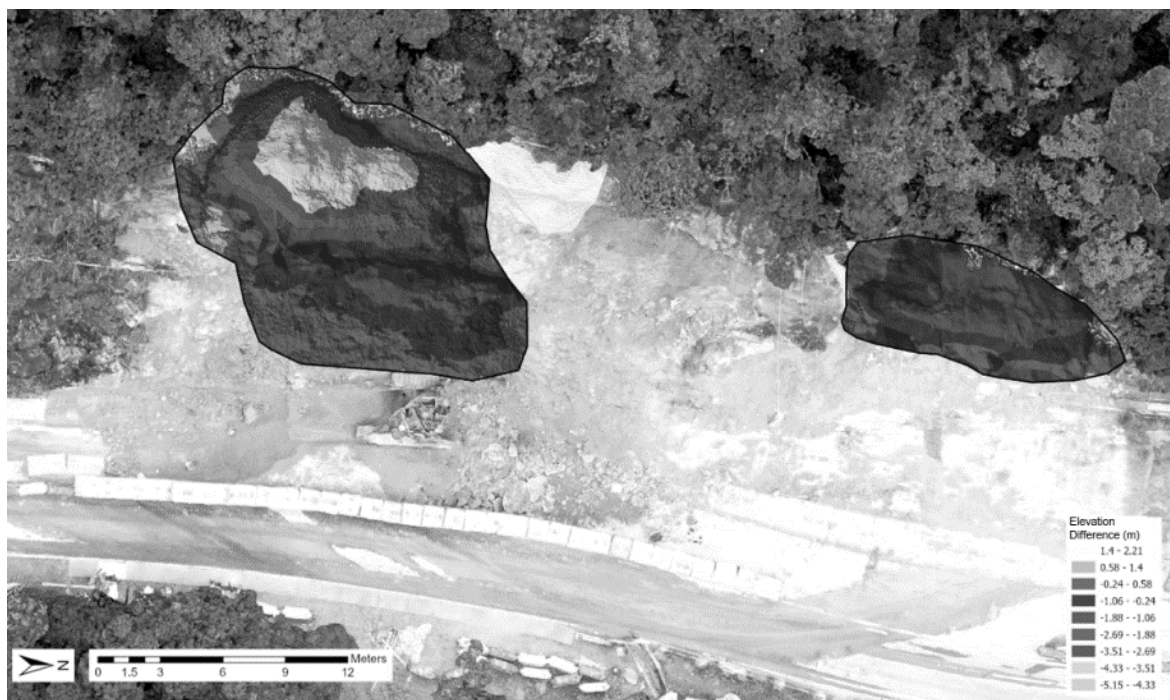
To better understand the extent of the landslide, a change detection analysis was carried out. This involved comparing the 3D point cloud model generated from the photogrammetric data of the UAV survey, with the pre-failure slope profile captured by the Light Detection and Ranging (LiDAR) survey in 2020 (Figure 9). The analysis indicated that the main and secondary scars had a failure volume of about 250 m³ and 47 m³, respectively, resulting in a total failure volume of about 300 m³. These results were consistent with the field observations and mapping results.

Figure 9. Change detection analysis

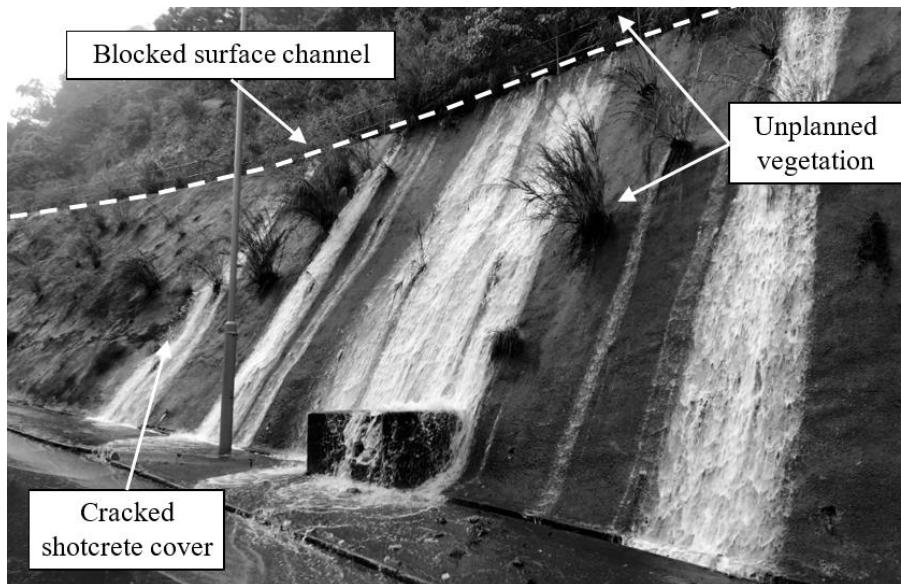
Site inspections revealed several defects on the slope, including extensive blockage of surface channels, catchpits and weep holes, growth of unplanned vegetation on the slope surface, and cracking and spalling of the shotcrete cover. The blockage of the surface drainage system led to significant surface overflow from the intermediate slope berm during the rainfall (Figure 10). Trees and shrubs growing in the surface channels, catchpits and shotcrete cover indicate that the undesirable conditions had been developing for a long time, possibly in the order of years.

Figure 10. Surface overflow from the intermediate slope berm

Inadequate slope maintenance is one of the key contributory factors to the landslide. Coupling effects of slope defects, such as cracked shotcrete cover, blocked surface channels and weep holes, could have exacerbated a sizeable failure even under a moderately intense rainstorm (Ho & Lau, 2010; Lo et al., 1998; Wong & Ho, 2000). The growth of unplanned vegetation in weep holes and surface channels would impede the intended slope drainage functions and cause significant spalling and cracking of the hard surface cover. Apart from hampering the surface protection function, this could provide a pathway for direct water ingress, possibly promoting landsliding. The landslide reaffirmed the importance of proper and regular slope maintenance to retard slope deterioration and upkeep the conditions of prevailing slope surface protection and drainage provisions (Cheung, 2021; Geotechnical Engineering Office, 2023; Lee et al., 2018).

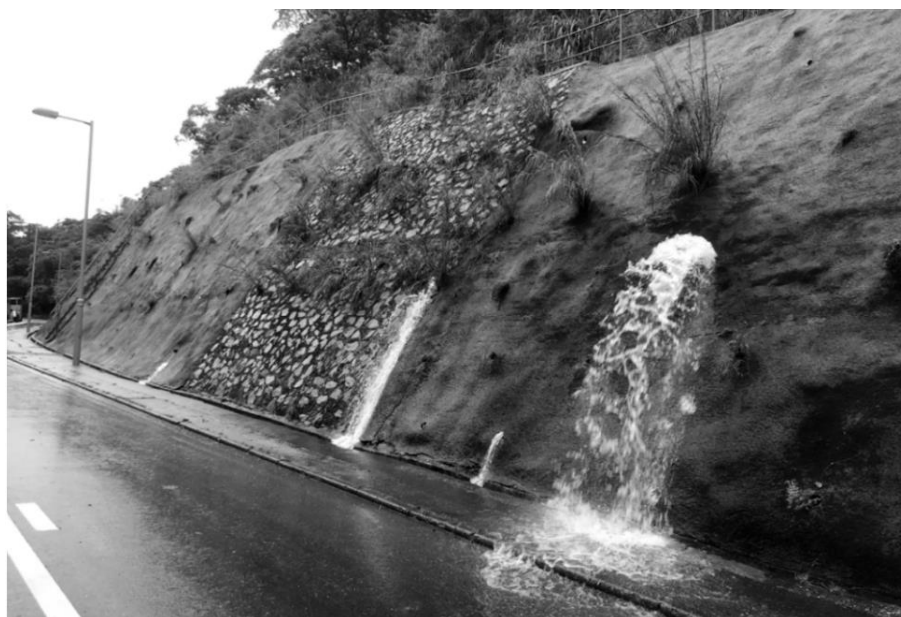
During the time of the landslide, a zone of heavy seepage was observed in the intact portion of the slope, which is about 120 m south of the landslide site (Figures 1 and 11). The localised nature of the heavy seepage indicates it could be related to specific hydrogeological conditions of the slope.

Figure 11. Heavy seepage in the intact portion of the slope

The heavy seepage zone was observed from weep holes in the intact portion of the slope, some 120 m south of the landslide site (Figure 11). The catchment upslope has an area of about 1.1 hectares and

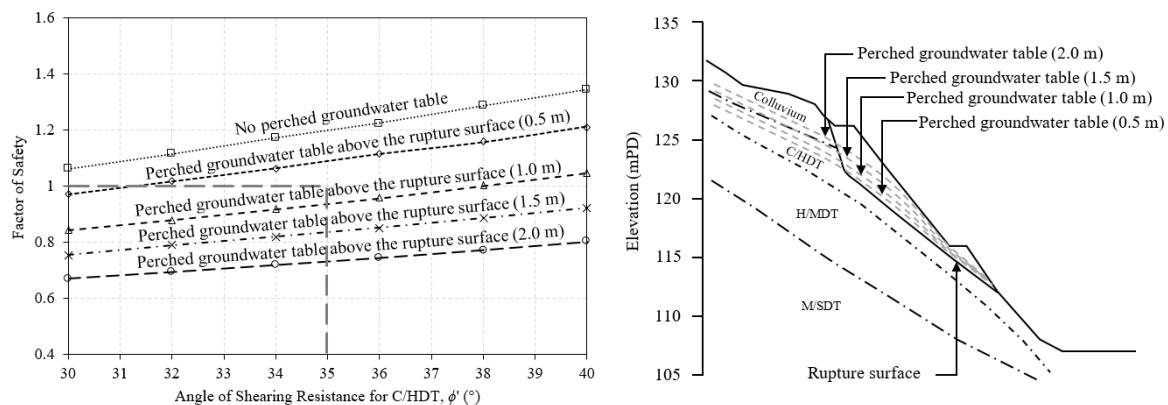
According to the results, the factor of safety of the soil mass that failed in the landslide would be less than unity when a perched groundwater table had risen to 1.8 m above the H/MDT layer, i.e. 0.8 m above the rupture surface (Figure 12). These findings are based on the shear strength parameters listed in Table 1. The site-specific ground investigation shows that the H/MDT layer is relatively less permeable than the colluvium and C/HDT strata. This allows the perched groundwater table to rise above H/MDT and reach the soil mass of C/HDT.

Figure 12. Summary of slope stability back-analyses

The slope stability back-analyses indicate that the slope could fail if a transient perched groundwater table builds up above the H/MDT layer. The loss of shear strength of C/HDT eventually led to the collapse of the soil mass, with a rupture surface developed along saprolitic soil.

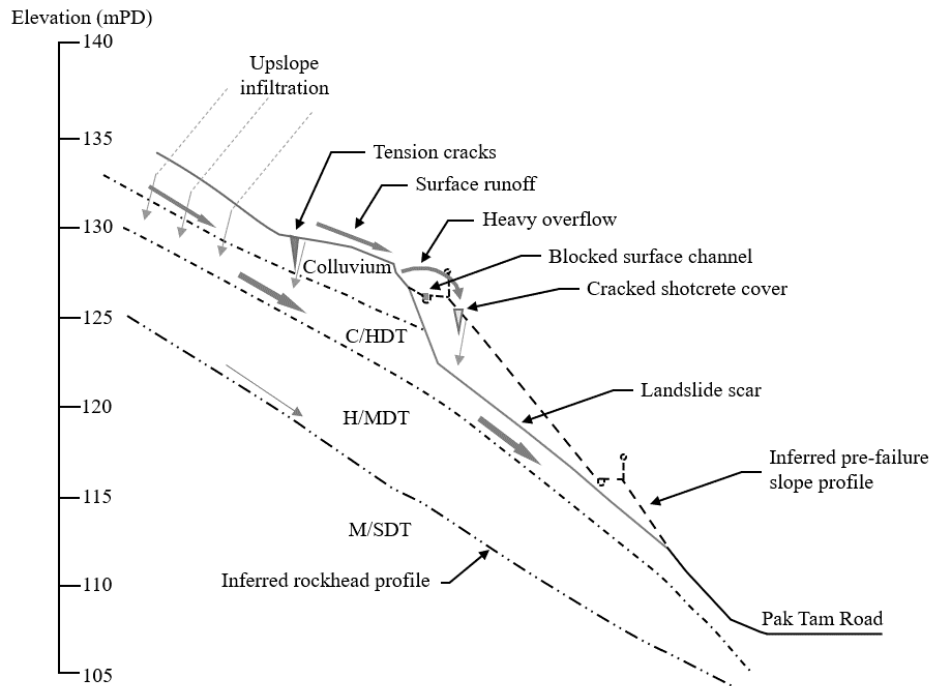
The defective surface drainage and damaged shotcrete cover could have enhanced direct infiltration to the landslide site (Figure 13). The blocked U-channels in the slope crest failed to divert surface runoff from the upslope catchment but aggravated water ingress to the underlying soil through the prevalent cracks on the shotcrete cover. This, in turn, caused local erosion and elevated pore water

pressures. The existing tension cracks along the slope crest could have further facilitated direct infiltration into the slope. With the presence of abundant water sources, subsurface flow could have developed in the permeable layers of colluvium and C/HDT, and converged towards the landslide site under a setting of locally depressed rockhead. Due to unplanned vegetation blocking the weep holes, groundwater pressure behind the shotcrete cover could not be relieved from the slope properly. This could have provided the hydrogeological conditions favourable to the rapid development of a transient perched groundwater table above the less permeable layer of H/MDT to the stratum of C/HDT. This is supported by the results of the slope stability back-analyses.

Figure 13. Cross-section A-A' of the main scar

Given the highly heterogeneous ground conditions in weathered rock profiles, those subtle adverse geological features may be difficult to detect and assess in the design stage. Hence, a pragmatic approach to managing the landslide risk is to use more robust design solutions, such as soil nails with prescriptive raking drains, which are less sensitive to uncertainties or undetected weaknesses (Ho et al., 2016; Pun et al., 2019).

Following the landslide, the slope was stabilised by a robust design solution, in the combination of soil nails and raking drains, under the Landslip Prevention and Mitigation Programme. The stabilised slope remains intact after several rainstorms, including the record-breaking rainstorm in September 2023. This demonstrates the robust design solution is less sensitive to local adverse geological and groundwater conditions in comparison with unsupported cuts.

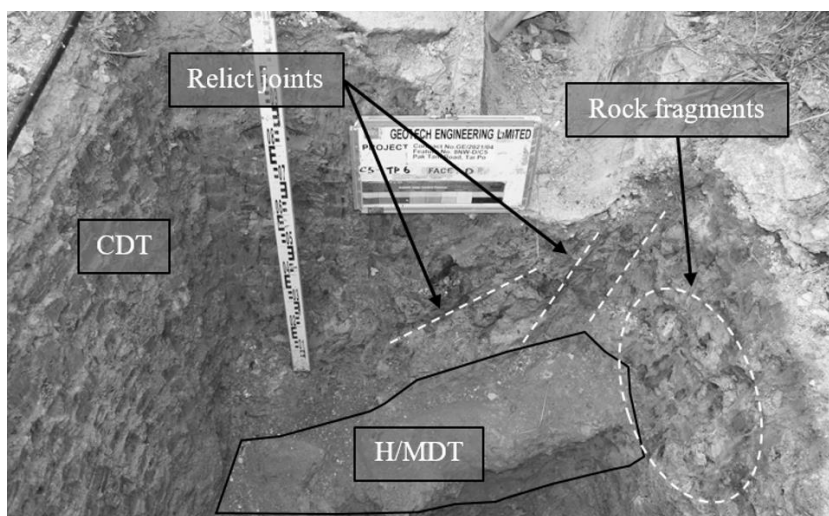
Apart from the landslide site, the site-specific ground investigation was also carried out in the intact portion of the slope and the natural hillside above. A vertical drill hole and a trial pit at the heavy seepage zone encountered CDT with coarse gravel and cobble-sized rock fragments and abundant relict joints daylighting out of the slope. These relict joints have similar orientations as found in the main scar to the south (Figures 14 and 15). They could have facilitated infiltration and provided pathways for groundwater flow in saprolitic soil. An area of localised depressed rockhead was also mapped at the heavy seepage zone.

Figure 14. Ground condition in the trial pit

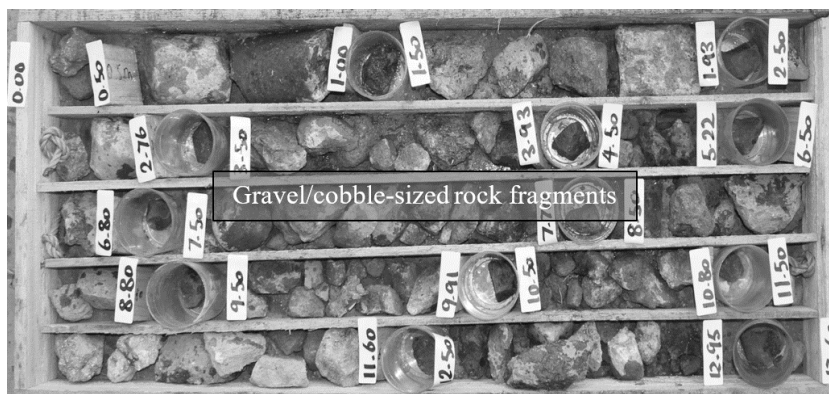
Figure 15. Samples of rock cores from the vertical drill hole

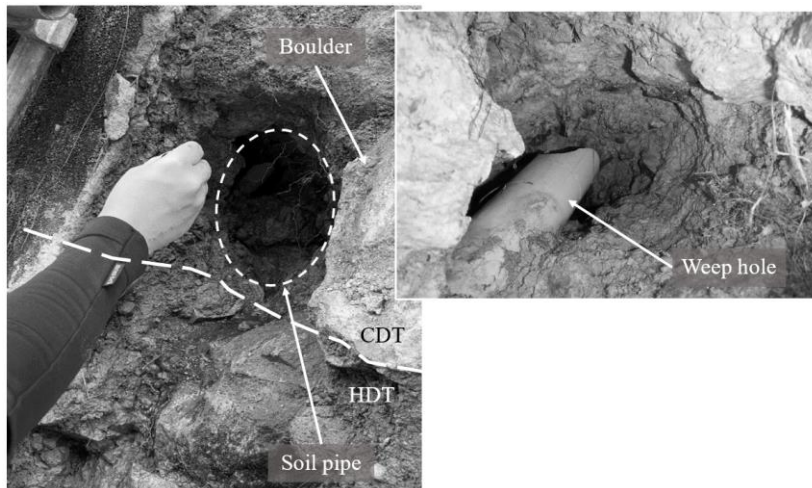
Surface stripping of the shotcrete covers was conducted to expose soil pipes in the heavy seepage zone. The soil pipes were measured up to 250 mm in diameter and 1.5 m deep, connecting to weep holes (Figure 16). These pipes were typically located in CDT that was characterised by sandy clayey slit and close to a less permeable HDT interface below. This formation created preferential flow paths for groundwater to be discharged from the slope, and the water was observed flowing from the weep holes, as shown in Figure 11.

Figure 16. Soil pipe exposed from the surface stripping

The large trajectory of water flowing from the weep holes suggests that the water was subjected to a transient build-up of a high-pressure head due to the impermeability of the shotcrete cover and the blockage of surrounding weep holes by unplanned vegetation, causing the back up of groundwater in the slope. The soil pipes could have developed progressively from pre-existing relict joints and eroded headward, forming a relatively large opening.

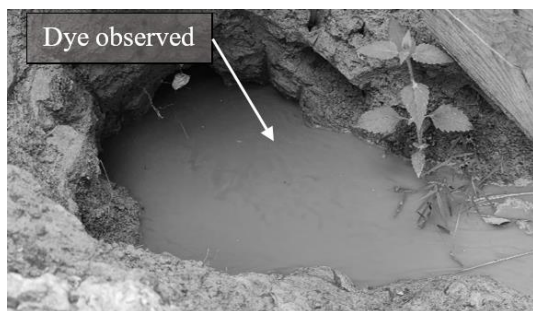
Permeability tests were carried out in drill holes in the natural hillside above the slope. It was determined that the permeability of colluvium and CDT was about 10^{-5} m/s, while HDT was about 10^{-7} m/s, indicating an interface of contrasting permeability. During the permeability test in one of the drill holes, water was observed flowing from the soil pipe, about 35 m downslope of the drill hole. A dye test was carried out in the drill hole to confirm the source of the flowing water (Figure 17). The test result found that the dye flowed to the soil pipe in about ten minutes, equivalent to a rate of about 10^{-4} m³/s.

Figure 17. Observations on the soil pipe during the dye test

The permeability measured in the groundmass is unlikely to convey groundwater through the slope at the rate observed in the soil pipe. It is considered credible, with support from the observations in trial pits and surface stripping, that the drill hole intersected a network of soil pipes and relict joints which were directly connected to the weep holes at the heavy seepage zone.

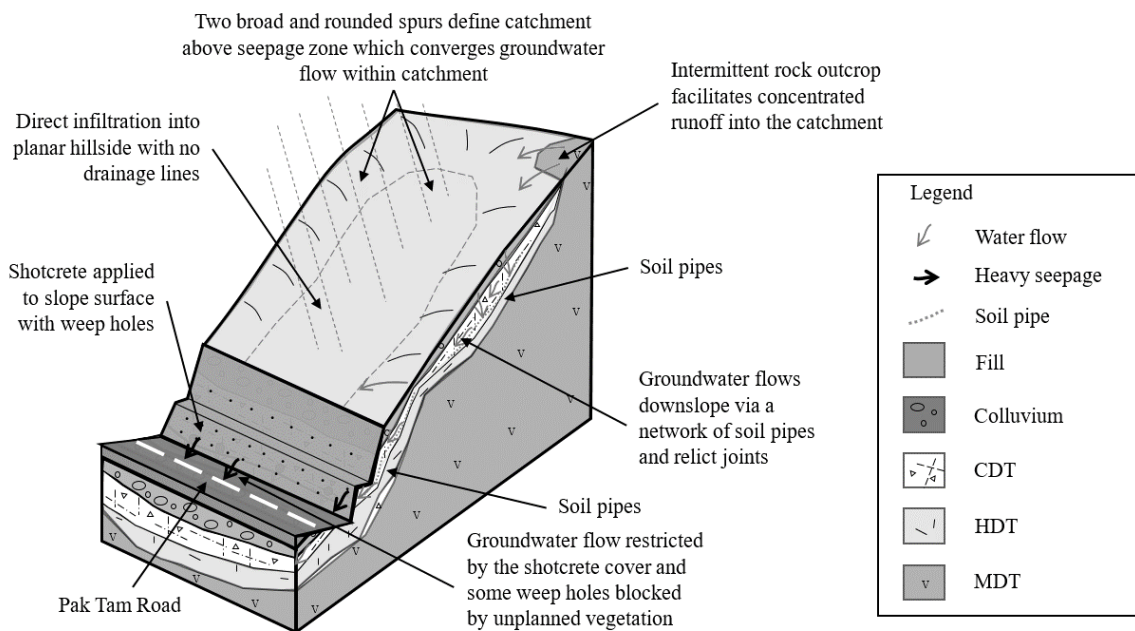
A ground model in Figure 18 illustrates how groundwater flows through the heavy seepage zone. It is postulated that direct infiltration and surface runoff from the upslope hillside could have converged on the catchment bounded by broad and rounded spurs. The surface water infiltrated into the groundmass and flowed along the network of soil pipes and relict joints preferentially, heading to the zone of heavy seepage under a setting of depressed rockhead. Some weep holes were blocked by unplanned vegetation, which caused the groundwater to back up and exit at nearby open weep holes at a greater pressure, resulting in a large trajectory observed at the site. These hydrogeological conditions could have caused the slope susceptible to internal erosion and landsliding.

Figure 18. Conceptual ground model of the heavy seepage zone

The investigation of the heavy seepage zone revealed that the local site setting and geomorphology are conducive to active groundwater flow downslope via upslope catchment, permeable surficial soil strata, and network of soil pipes and relict joints developed at interfaces of permeability contrast. When this natural system is modified by slope formation with a shotcrete cover, it is crucial to ensure adequate subsurface drainage measures are provided for and maintained to prevent the build-up of excess groundwater pressures and consequent deterioration of slope stability.
