Type of Rockslide along the Ponorogo – Pacitan Roads, East Java, Indonesia

Arief Rachmansyah^{1,*} and Faridha Aprilia²

ABSTRACT The Pacitan Regency, located in the southwestern part of East Java Province, is one of the areas with low economic growth. Difficult accessibility is one of the reasons for the slow development of this region. To reaching the Pacitan Regency it can take through the Ponorogo – Slahung – Arjosari - Pacitan roads. Based on the geological condition most of roads are built on geologic formations composed of Oligocene - Miocene volcanic and intrusive rocks. Mass movement often occurs along roads and disturbs the transportation of goods and people. This paper discusses the types and mechanisms of slope failure along roads. Recognizing these two aspects of slope failure plays important role to treat them. The field survey identified 13 landslide zones with a 50–200 m bright. Based on rock type, weathering and alteration levels, and geological structure, slope failure can be classified into three types. First, the wedge rockslide occurred on the low-altered dacitic lapilli tuff. The planar – toppling type of rockslide occurred in the residual soil of the andesit

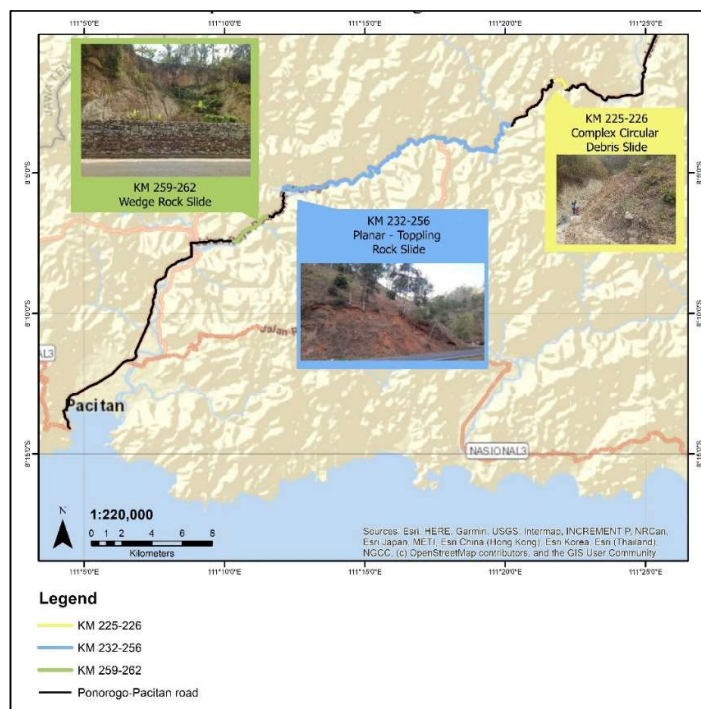
Figure 3. Type rock slide on the Ponorogo – Pacitan road and its distribution

Along the Ponorogo - Pacitan road, there were at least 13 landslide points with widths of 50–100 m. Based on the material, geological structure, and slide plane, they can be grouped into three types: Wedge Rockslide, Planar – Toppling Rockslide, and Complex Circular Debris Slide (Figure 3 and Table 1).

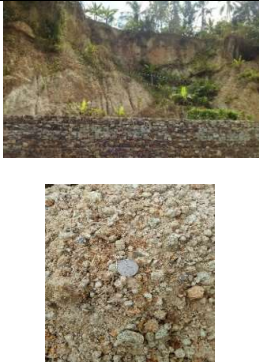
This type of slope failure happened at km 259 to 262 of the Ponorogo - Pacitan road. The height of the slope varied between 8 m and 10 m. The average dip of the slopes ranged from 60° to 75°. The debris material consisted of a mixture of angular gravel of lapilli rock, tuff, and clayey soil. Lapilli, tuff, and lapilli tuff are parts of the Arjosari Formation. The existence of clay in the rock indicates

that the alteration process occurred. Based on Terzaghi's Rock Mass Classification, the rock mass was classified as crushed rock.

Based on geological descriptions, it had an estimate of $GSI = 45$, whereas the RMR analysis obtained a value of 54. The RMR value can be classified as a fair rock mass (class III). In addition, from the SMR analysis, it was included in Class IV. This class is normal and unstable slope. The probability failure of planar or big wedges are more than 0.6. The recommended slope support methods that can be used in this case are shotcrete and dental concrete.

The slope failure occurs on low altered of dacitic lapilli tuff rocks. There is clay material as alteration product. Based on Terzhagi's Rock Mass Classification, the rock mass materials classify as crushed rock.	<i>Wedge Rock Slide</i>

GSI = 45 RMR = 54 (Fair Rock) SMR = IV (Bad, unstable, big wedges failure, failure probability 0.6)
2

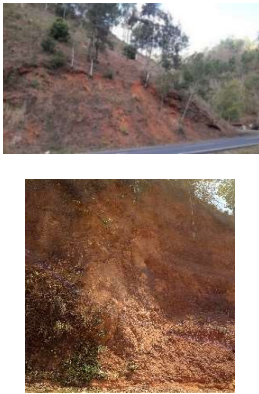
This type of mass movement occurs on basaltic andesitic rocks. This lava volcanic rock has a columnar and sheeting joint structure, and the thickness of the weathered zone is 30–150 cm. After Terzaghi's Rock Mass Classification, the material can be classified as moderately jointed rock, which occurs between 232 and 256 km. The dip of the slope was $75\text{--}85^\circ$. The planar rockslide begins by the movement of weathered rock, then is followed by the collapse of the rock mass. The direction of rock toppling failure is like the dip of the slope.

Based on the results of the GSI and RMR analyses, the values obtained sequentially were 83.25 and 74. Based on this RMR value, the rock mass is categorized as a good rock class (class II). In addition, based on the SMR method, the slope was classified as Class III. This implies that it is a normal and partially stable slope. Some joints may be observed in this typical slope failure, with a failure probability of approximately 0.4. Bolting and anchoring can be used as the recommended slope support method in this case.

The slope failure occurs on the high weathered zone of basaltic andesite lava with columnar joint structure. After Terzhagi's Rock Mass Classification, the material can be classified as moderately jointed rock.	<i>Planar Soil Slide – Toppling Rock Slide</i>

GSI = 81.25 RMR = 74 (Good Rock) SMR = III (Normal, partially stable, some joint failure, failure probability 0.4)
3

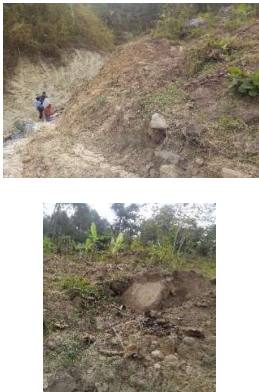
This type of slope failure occurs at kilometers 225–226, and the dip of the slope is between 65° and 75° . Rock mass materials are composed of highly jointed and altered dacitic intrusive rocks; there are many clay minerals as product of pyrophyllite alteration. Some outcrops of unaltered dacitic rocks were still found. According to Terzaghi's Rock Mass Classification system, the material can

be classified as blocky or steamy rock. Among these three types of landslides, this complex debris slide has the widest distribution and causes road damage.

The results of the rock mass analysis showed that this type of failure has a value of $GSI = 31.5$ and $RMR = 39$. The rock mass of this slope was categorized as a poor rock class (class IV) since its RMR value. For the SMR analysis results, the slope was included in Class V. The presence of faults or rock formation boundaries also contributed to the collapse at this location. The slopes in this class were completely unstable and in very poor conditions. The probability failure of a complex circular debris or soil-like is up to 0.9. The recommended slope support methods used in this case were re-excavation walls and drainage installation (both surface and deep drainage).

The complex circular debris slide which located at kilometer 226 needs to be further researched using various methods, to determine the depth of the slip plane, the presence of geological structures and groundwater. This complex debris slide causes road damage along 200 meters, and also has the potential to cut off the Ponorogo - Pacitan road.

This type of slide occurs on phyrophilic alteration of intrusive dacitic rock. Dacite is high jointed with close spacing. Based on Terzhagi's Rock Mass Classification system, the slide material can be classified as blocky and steamy rock.	<i>Complex Circular Debris Slide</i>

GSI = 31.5 RMR = 39 (Poor Rock) SMR = V (Very bad, completely unstable, soil like failure, failure probability 0.9)
