Sheet Pile Failure Caused by Scouring and Sand Mining at Padang River Bank

Hansen Tananda^{1,*}, Andy Sugianto² and Paulus P. Rahardjo³

¹Geotechnical Engineer, PT. Geotechnical Engineering Consultant, Bandung, Indonesia; hansenananda91@gmail.com

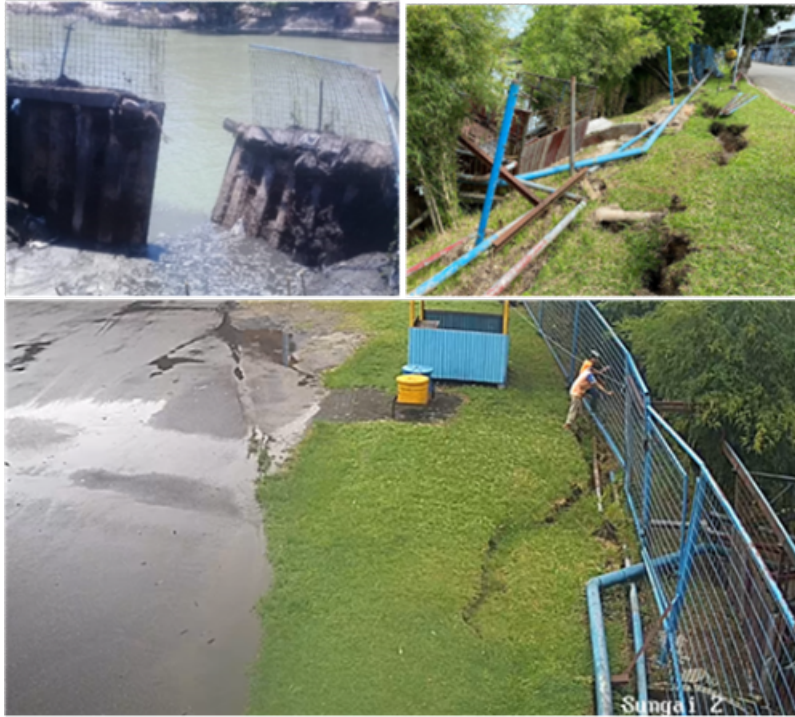
Figure 2. Soil movement documentation (September 30th, 2021)

Figure 2 shows the condition of the sheet pile that has experienced deformation and the condition of the factory area which has decreased due to soil movement.

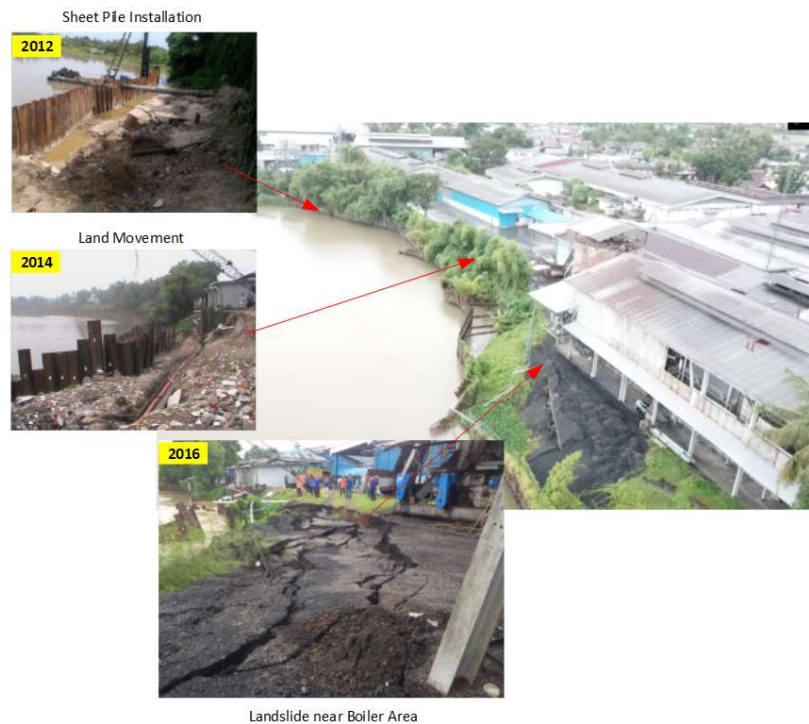
Figure 3. Landslide chronology documentation

Figure 3 depicts the sheet pile piling work in 2012. It is noticeable that the piling was done near the river. In the documentation of ground movement from 2014, it was discovered that the penetration depths of the sheet piles were not uniform. Another land movement happened in another location in 2016.

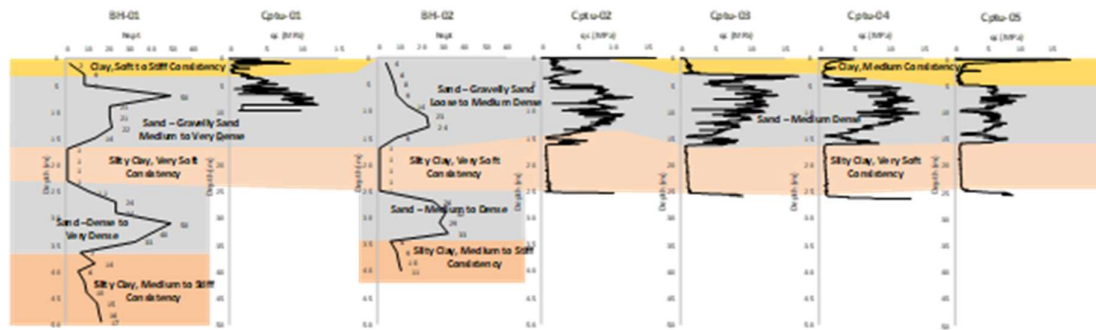
Soil conditions based on drill data and CPTu (Piezocone) are consistent, where the soil layer is dominated by soft clay on the surface with a thickness of 2m to 5m. The second layer is gravelly sandy soil with loose to moderate density to a depth of 15m. The third layer is very soft clay, which is uniformly found down to a depth of 25m. The CPTu test ended at this depth due to limited penetration and hard soil. The next layer is interpreted based on drill data, where the next layer is dense sandy soil to a depth of 35m. The next layer is silt clay of medium to stiff consistency, which was encountered until the end of the drilling at a depth of 50m. Figure 9 shows the estimated soil stratification based on piezocone data and technical drilling in 2022.

Figure 9. Soil Stratification Interpretation of Latest Soil Investigation

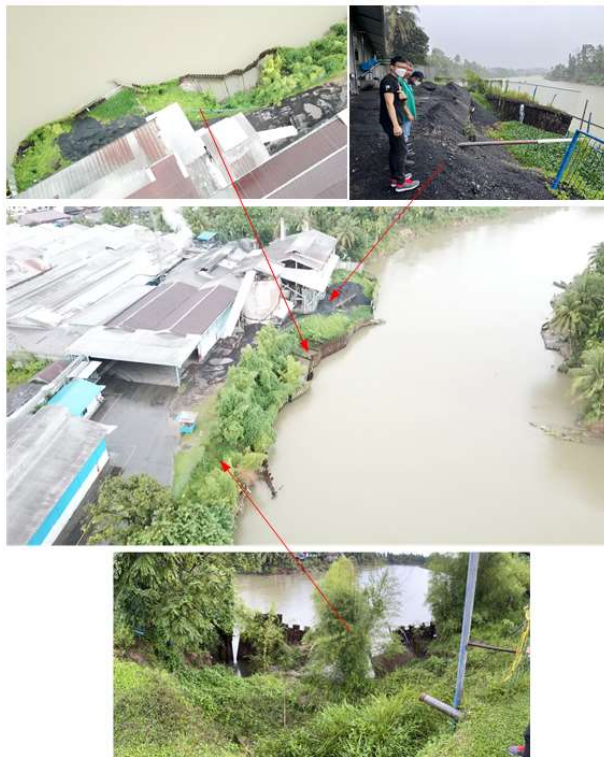
Based on aerial photos taken during the site visit in 2022, there was a wide gap of 10-12 meter between the sheet pile and the Factory site. It was expected that the sheet piles condition are in critical condition because most of the sheet pile structures are no longer embedded below the ground. Figure 10 below shows the situation in the Factory area from an aerial view and the sheet pile conditions.

Figure 10. Sheet Piles Movement in 2022

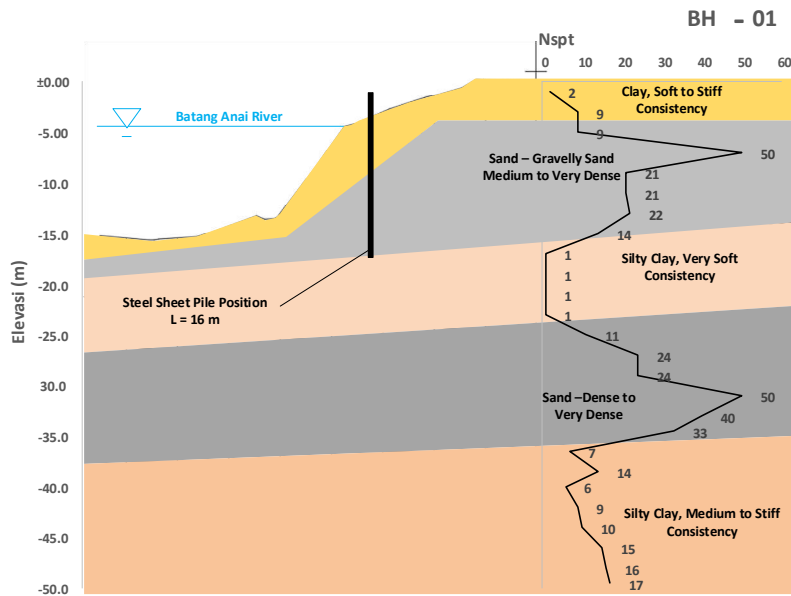
Based on site observation, the landslide mechanism that occurs is caused by the material behind the sheet pile being scoured so that the soil resistance is reduced. Referring to the technical drilling data that has been carried out, it can be seen that at the foot of the sheet pile, there is a layer of very soft soil, which can have an impact on the lack of resistance so that the sheet piles are unstable.

Figure 12. Sheet piles on soil stratification

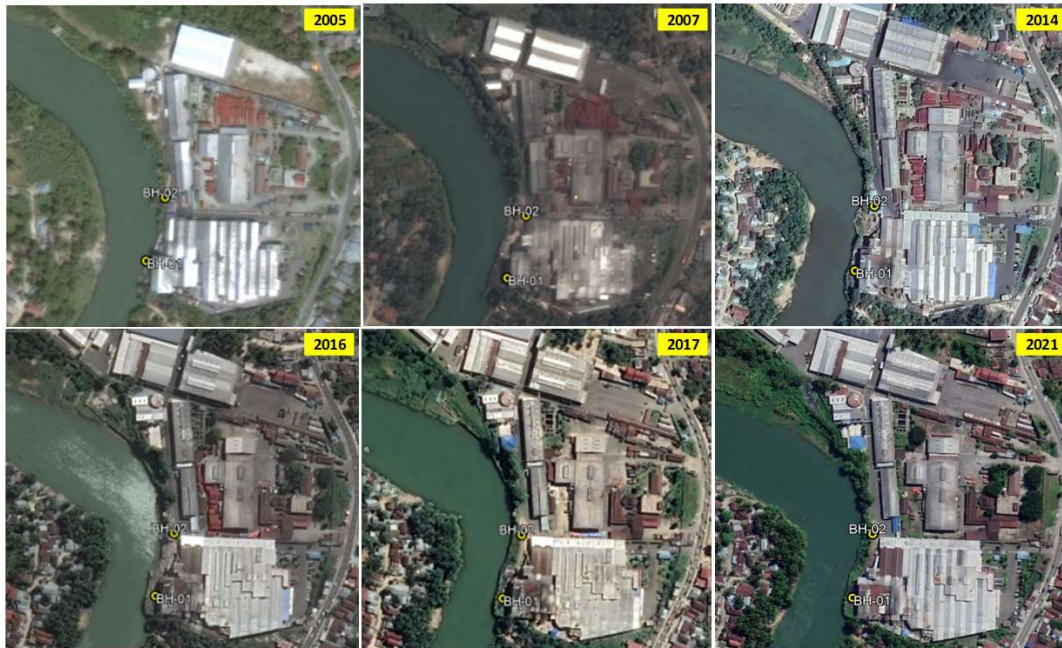
Based on the Figure 13 below, it can be seen that part of the land area beside the Factory is suspected as embankment material. In 2021 it can be seen that Factory land is increasingly being eroded towards buildings. Briaud (2008) explained that the input to an erosion problem is always three fold: the soil or rock, the water, and the geometry of the obstacle that the water is encountering. Meanwhile, Duong and Do (2019) also found that Riverbank failure occurs by multiple factors,

Figure 13. Land development history (source: Google Earth image)

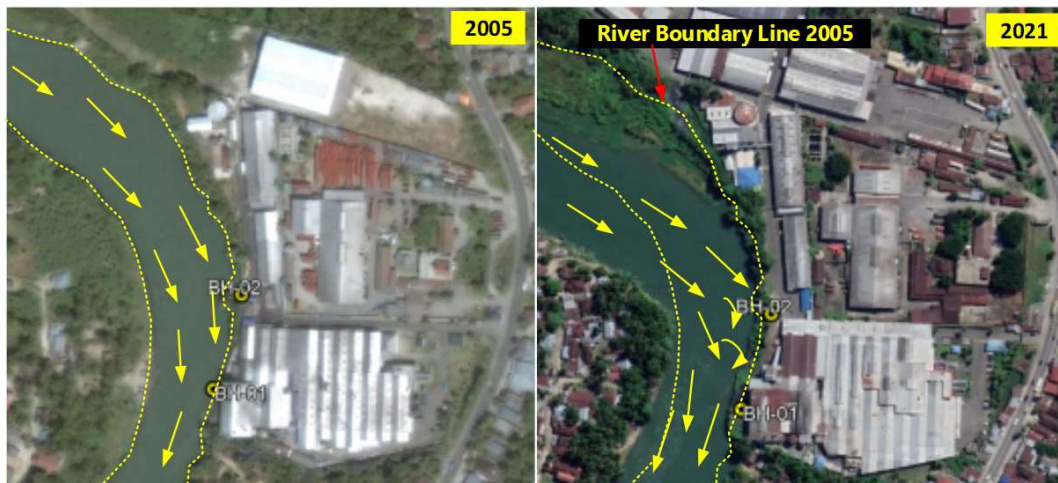
Based on images of the land development history as shown in Figure 14, the position of the BH-01 drill point which was conducted in 2022 was formerly part of the River area. The embankment material is suspected of experiencing scouring and landslides. It is suspected that the soil condition of the embankment has not been adequately compacted so that scouring occurs easily.

Figure 14. Changes in the flow pattern of the river

Based on the 2005 satellite imagery compared to the 2021 data, it can be seen that the appearance of the river has changed, which has caused the river to flow directly into the factory land area.

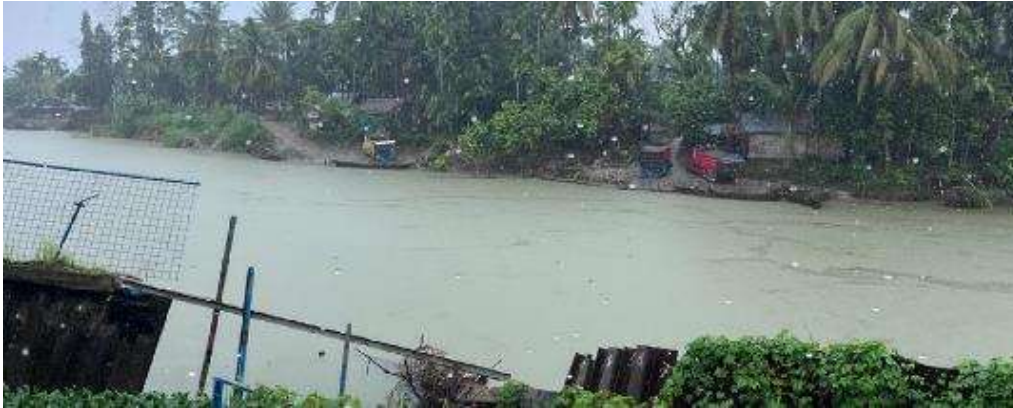
Figure 15. Sand mining around riverbanks

Land movements and landslides occur due to changes in the flow patterns of the River, which occur gradually due to two factors. The first factor is caused by the flow and behavior of the river itself, while the second factor is the mining of sand and soil materials around the riverbanks. Sand mining around riverbanks shown in Figure 15.

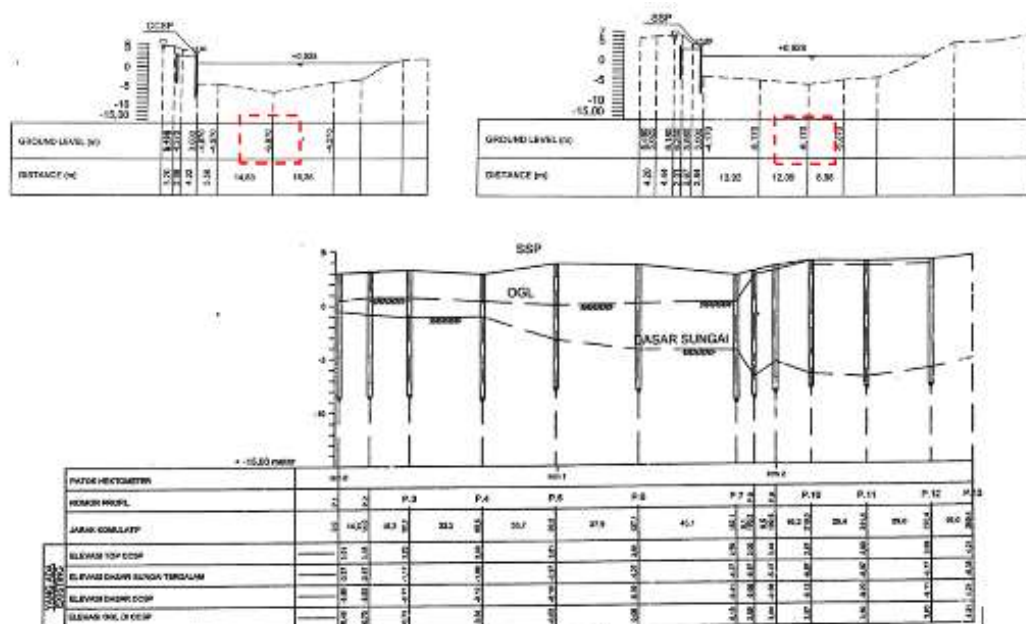
This change in flow patterns is confirmed by a comparison of the 2012 cross section drawing to the latest of 2022 cross sectional drawings. Based on those drawings, it is known that there is elevation difference between the deepest river bed and the river water level which deepens up to 3-4 meters over 10 years period. These are the two processes that most commonly cause bank instability. The process of lateral erosion increases the bed width of the channel and results in steepening of the bank, which reduces its stability. Bed lowering increases the bank height, which also decreases stability (Osman and Thorne, 1998).

Figure 17. River bed elevation in 2012 (7.1 – 7.9 meter below river water level)

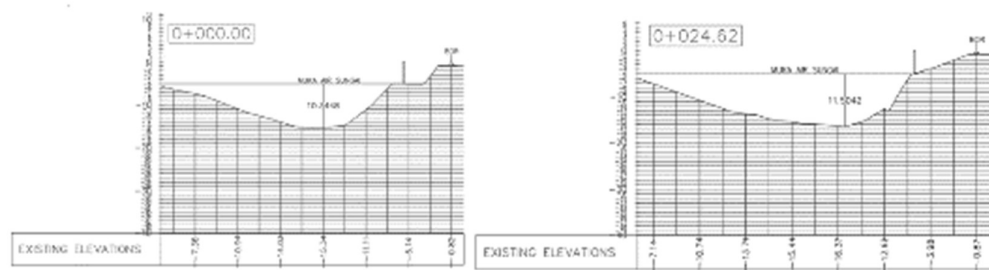
Figure 18. River bed elevation in 2022 (up to 11.5 meter below river water level)

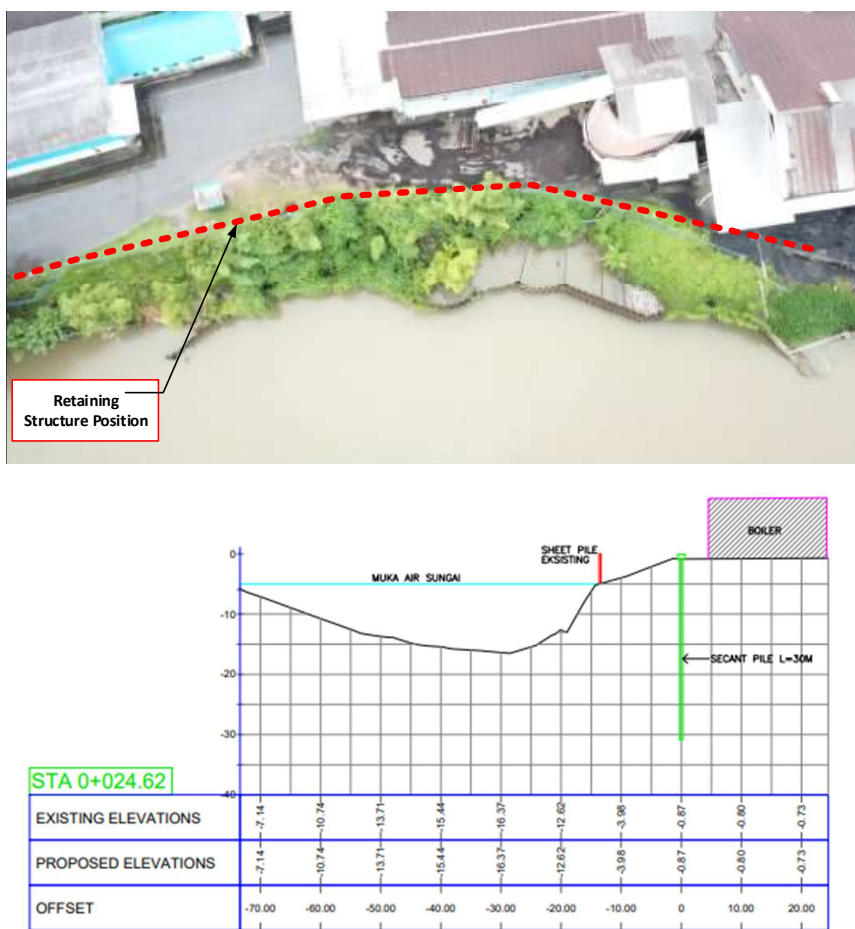
Figure 19. Secant pile position recommendation

In principle, a layer of soil that is unlikely to be scoured or that is a slipping plane must be reached by the length of the depth of the soldier pile or the retaining structure. The Figure 19 below presents the position of River slope reinforcement recommendation is located:

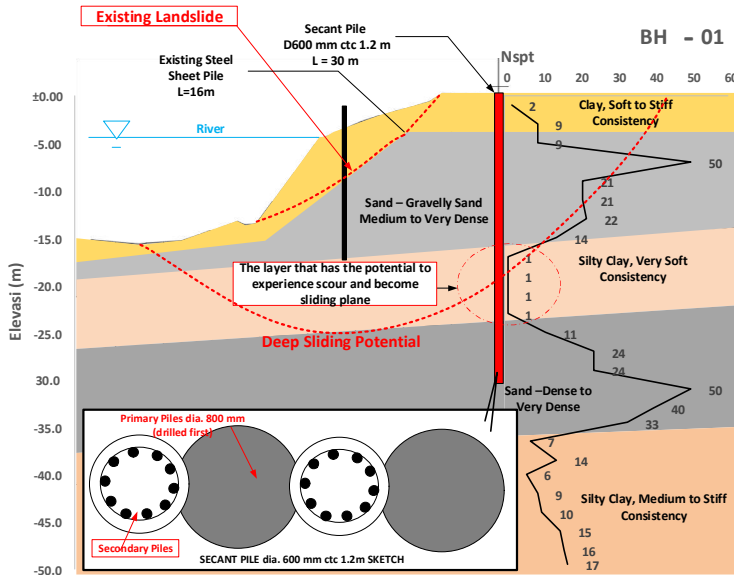
Figure 20. Secant pile illustration on slope

Figure 20 shows a sketch of the position of the secant pile placement on the existing slope that is experiencing land movement. Placement of secant piles is estimated to at least reach a depth of 30 meters in order to anticipate the potential for future landslides due to soft soil layers at a depth of 20 - 25 m.

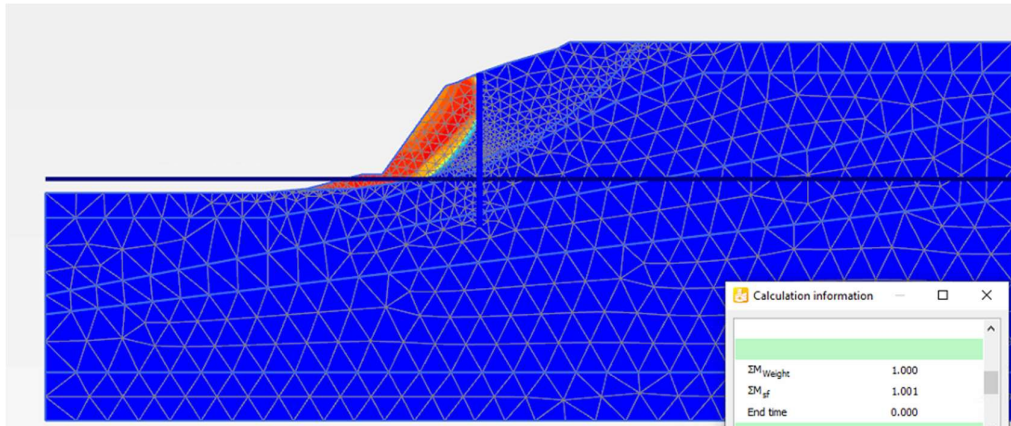
The initial slope analysis was carried out by modelling the existing condition of the slope where the factor of safety condition is 1.0. Back analysis is based on the cross section and the nearest soil investigation data. The results of the actual condition slope analysis using the help of the Plaxis 2D finite element program are shown in Figure 22. The shear strength reduction technique has a number

of advantages over the method of slices for slope stability analysis. Most importantly, the critical failure surface is found automatically (Dawson et al, 1999). The analysis results obtained that the factor of safety does not meet the allowable criteria, therefore reinforcement is needed.

Figure 22. Back-analysis result

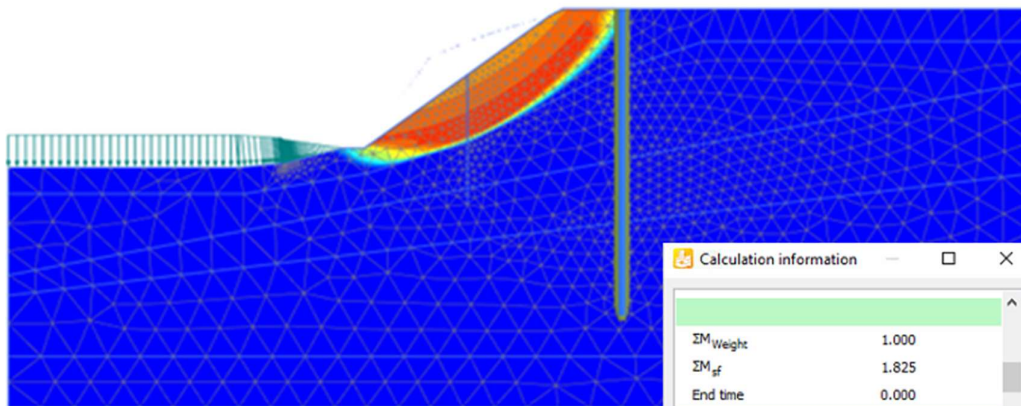
Figure 23. Slope stability analysis after reinforcement

The soil parameters from the back-analysis can be obtained with a residual friction angle as $\pm 20^\circ$. This value is used during the soil improvement process. The recommended reinforcement is to use secant pile D600 mm c.t.c 1.2 m. After installing the D600 mm ctc 1.2 m of Secant Pile, the slope stability safety factor is increased to more than 1.5 (Figure 23).
