Spatial Variability of Sliding Plane on Volcanic Region. Case Study of STA 21+200 Cisumdawu Toll Road

ABSTRACT Landslide can be caused either by natural phenomenon or due to human intervention. Regardless of the triggering factor, once landslide occurs, sliding plane in the form of discontinuity or sometimes referred as sliding plane is formed. Identifying the location and geometry of the sliding plane is important in determining the location of the reinforcement to rehabilitate slope failure. However, it is often difficult to locate the location and geometry of the sliding plane as the sliding direction is also difficult to ascertain. In this paper, slope failure which occurred in STA 21+200 of Cisumdawu toll road is used as case study. Variability of the sliding planes are investigated based on the location of the concrete overbreak that occurred during the bored pile construction on Tuff (volcanic soils) in Sumedang Region. Sliding planes are also estimated based on the soil investigation and pile boring records. The proposed solution is to reinforce the bored piles that did not penetrate into the hard layer with ground anchors installed at the pile cap.

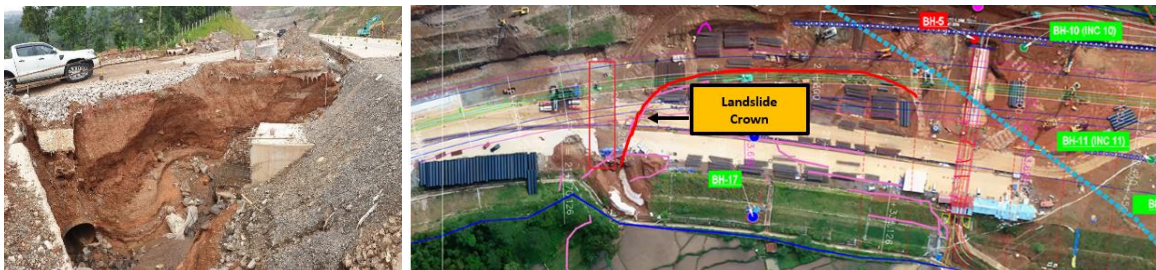
In December 2022, the Cisumdawu toll road on STA 21+200 experienced geotechnical problems related to landslides (Figure 1). There are presumptions that the cause of the slide was a material failure of the fill embankment which used tuff, a water-sensitive soil. The first geotechnical problem encountered was the damage of drainage channel made of box culverts. The damage was suspected to be caused by the movement of the embankment soil. Due to the damaged drainage channel, the flow of water became uncontrollable, further softening the embankment material and existing base soil, which is also consist of water-sensitive tuff.

Figure 1. Landslide in STA 21+200 Cisumdawu Toll Road

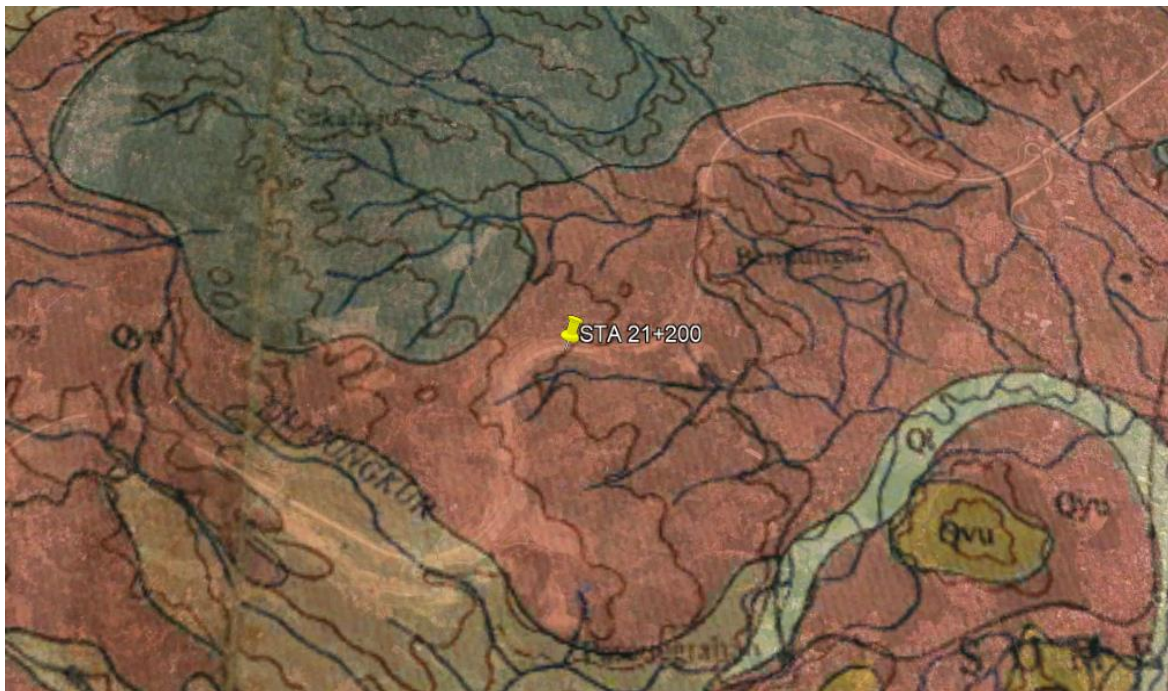
From the geological map of Bandung, it is known that the macro geological conditions of the STA 21+200 are in the Qyu formation (Figure 2), which means volcanic products, consisting of tuffaceous sand, lapilli, lava, agglomerates. The formation originated from Mount Tangkuban Perahu and Mount Tampomas. The area between Bandung – Sumedang, where the landslide occurred, is in a flat area or low hill area and is covered by reddish-gray and yellowish soil.

Figure 2. Landslide location on geological map of Bandung (Silitonga, 1973)

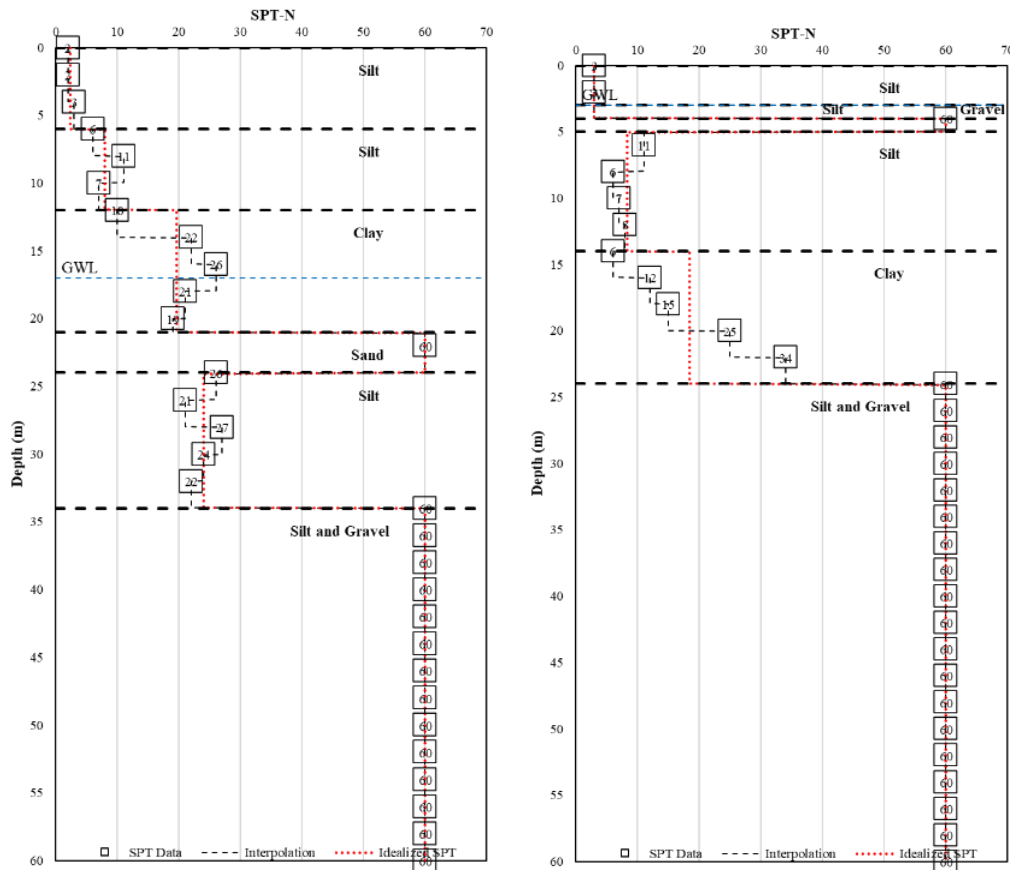
Soil conditions and stratigraphy are interpreted from soil investigation data in the field. There are two closest borehole data from STA 21+200, namely BH-16 and BH-17. The data shows that the soil layer is dominated by silt and clay layers. The hard soil layer ($N > 60$) is encountered at a depth of 35 m and 24 m for BH-16 and BH-17 respectively. The hard layer is made of Breccia, indicated as silt and gravel in the bore logs. The NSPT value of BH-16 and BH-17 is shown in Figure 3

Figure 3. Closest borehole data from STA 21+200: BH-16 (left); BH-17 (right)

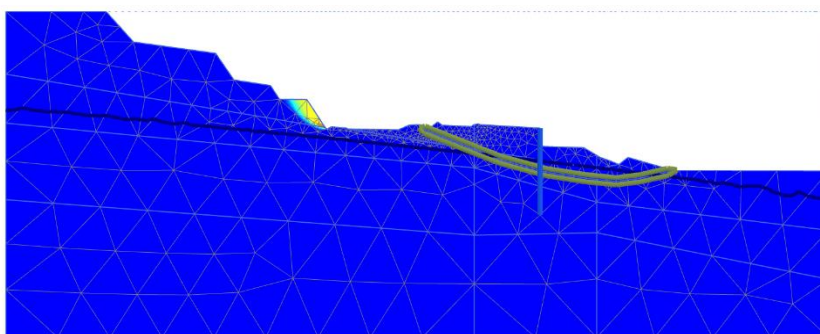
The initial proposal was to construct a retaining wall consisting of soldier pile with a diameter of 0.8 m, a length of 26 m and a center-to-center (c.t.c.) spacing of 2 m. Regrading is also needed in front of the soldier pile by cutting and reducing the elevation by about 6 m. A 2D finite element model (Figure 4) was run to analyze the safety factor of the proposed design. The safety factor obtained was 1.43. Based on the application required, the safety factor is considered sufficient, and the proposed design is carried out in the field with 80 bored piles.

Figure 4. Safety factor of slope after soldier pile construction and reggrading (SF = 1.43)

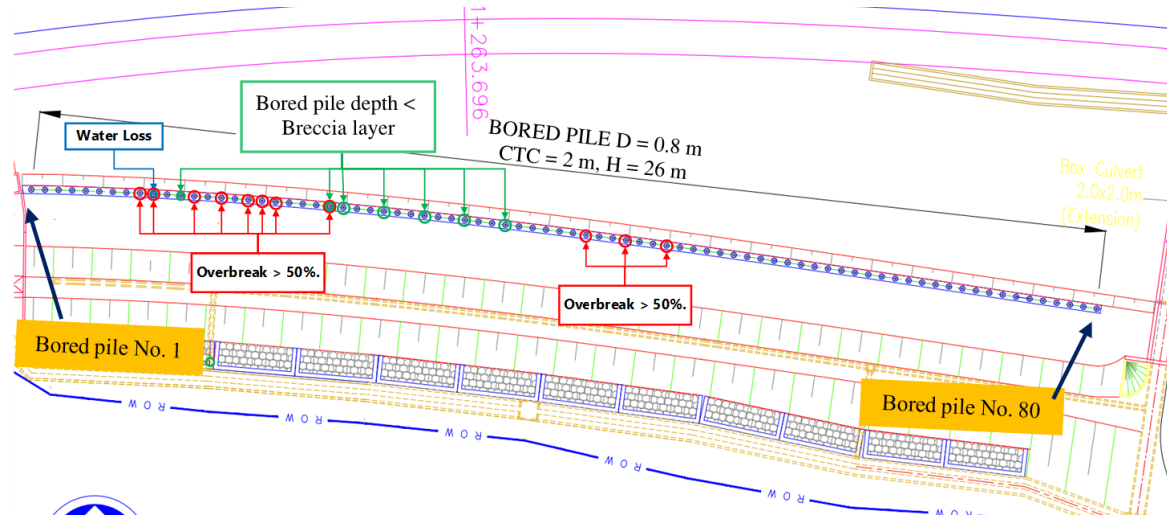
Hard layer depth can be obtained by visual inspection of bored pile cuttings. From visual inspection, hard soil layer was not reached at 7 bored piles (BP-12, BP-23, BP-24, BP-27, BP-30, BP-33, BP-36) indicated by green circles in Figure 5.

Figure 5. Mapping of constructed bored pile at STA 21+200 by 29 August 2022

From the pile boring records, it was suggested to increase the length of unconstructed bored piles (no. 46-80) to 36 m. The construction would resume by constructing indicator piles, which are pile numbered in multiples of 5. to the indicator piles were aimed to inspect the water loss and the depth of the hard layer for the 4 piles to be constructed between any two indicator piles.

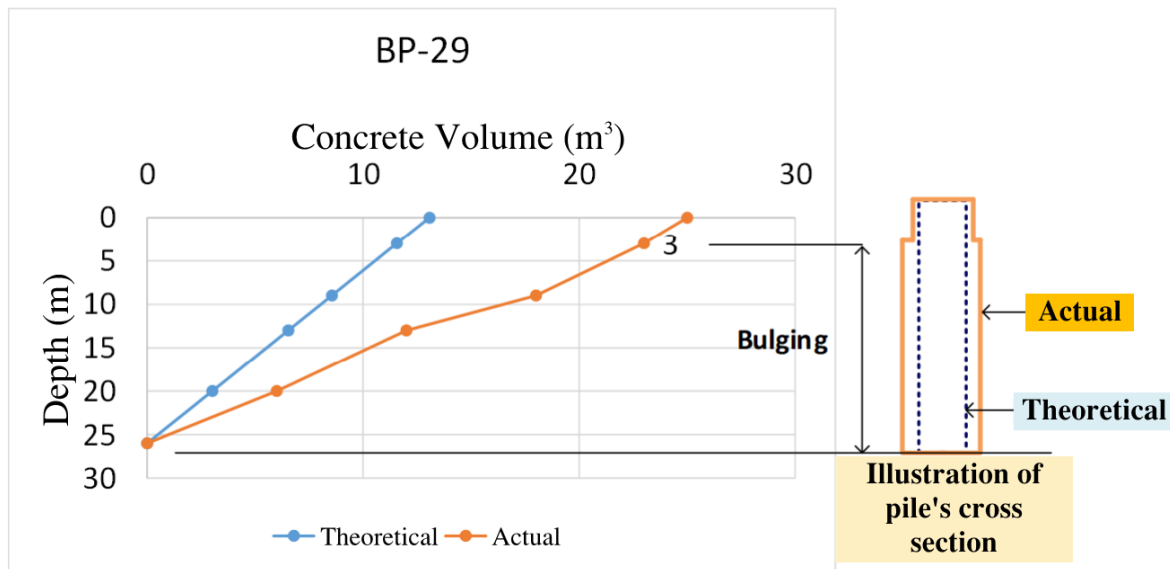
Bulging or necking conditions can be illustrated with a graphical comparison of the theoretical concrete volume and the actual volume of concrete poured as shown in Figure 6.

Figure 6. Graph of theoretical concrete volume vs. actual volume of concrete poured for BP 29 (88% concrete overbreak)

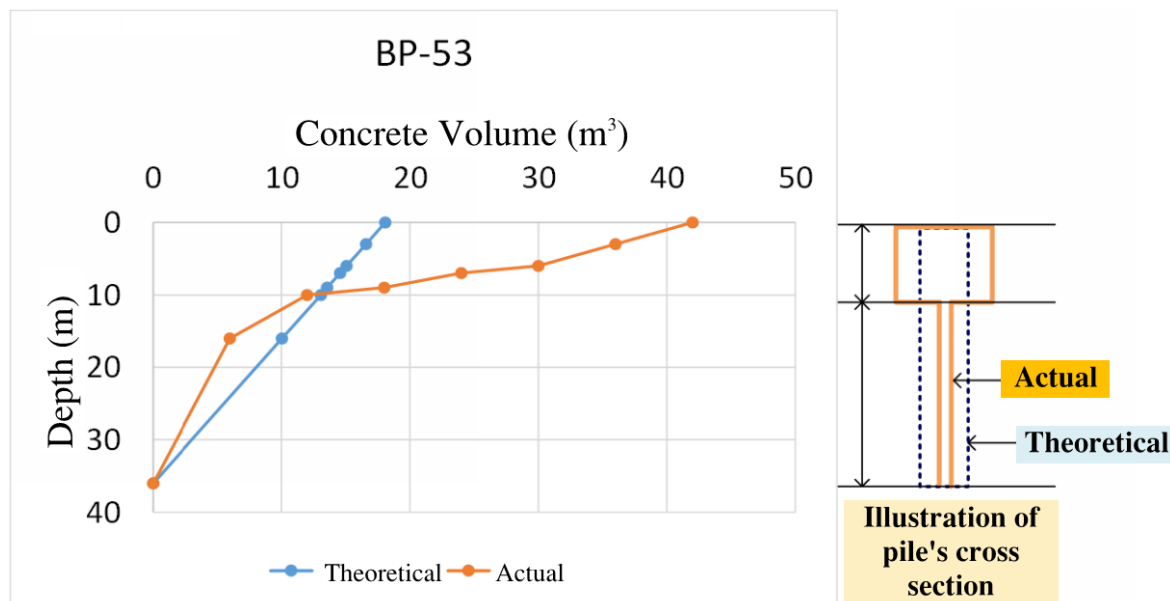
The most severe condition was recorded for BP 53, where necking occurred from the pile toe (36 m depth) to 10 m depth, followed by bulging until the pile head. The concrete overbreak for BP 53 is 153%. The graphical comparison of the theoretical volume and the actual volume of the concrete volume is shown in Figure 7.

Figure 7. Graph of theoretical concrete volume vs. actual volume of concrete poured for BP 53 (131% concrete overbreak).

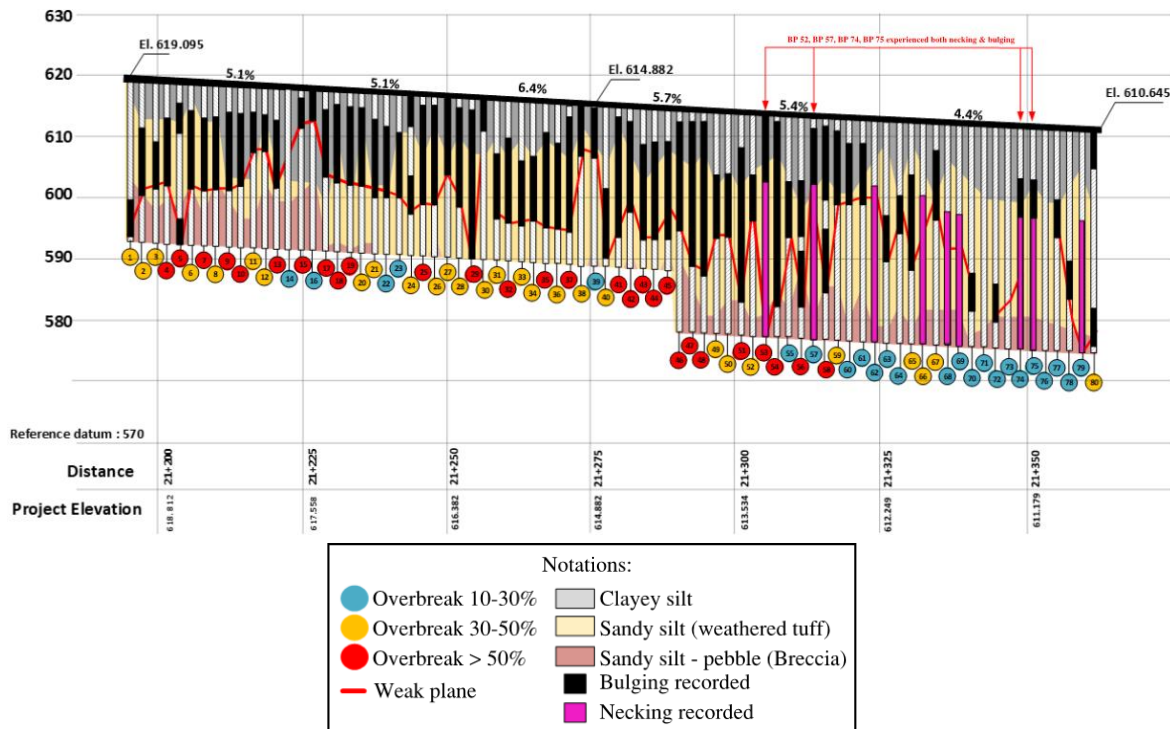
Figure 8 shows the concreting profile as well as the soil types from the drill cuttings. Bulging conditions are indicated by black block notations, while necking conditions are indicated by pink block notations (BP 53, BP 57, BP 62, BP 66, BP 68, BP 69, BP 74, BP 75, BP 79). The weak plane is estimated to be at the transition where concrete overbreak to non-overbreak occurred. The weak plane is found to be located at around 10-20 m from the ground surface.

Figure 8. Soil Profile and Pile Condition Base on drilling record STA 21+200

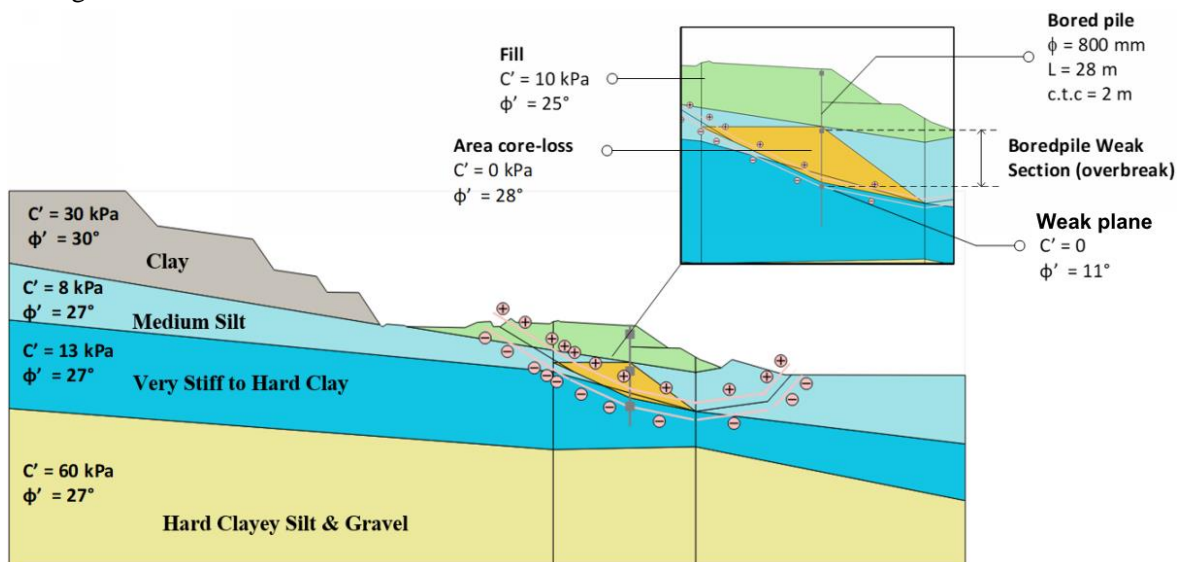
With the new information from pile boring and concreting records, the previous slope model is reanalyzed to take into account the existence of weak plane. Figure 9 shows the position of the weak plane which is modelled as interface element. The soil properties in the soil element are then altered until safety factor of 1 is obtained. Based on the back analysis, the weak plane has a friction angle of 11 degrees and cohesion of 0 kPa.

Figure 9. Back analysis of slope with weak plane (before failure)

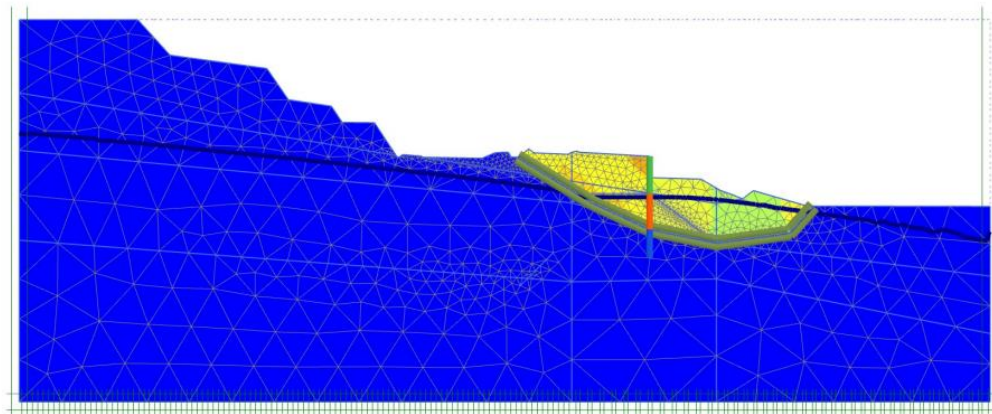
After obtaining the properties of weak plane, the previous solution (with soldier pile) is re-analyzed with the weak plane modelled. The results show that the factor of safety dropped from 1.43 to 1.20, meaning the previous solution no longer meet the requirement specified in the Engineering Guideline for Handling Slope Collapses on Residual Soils and Rocks (Pd-T-09 2005 -B). Hence, reinforcement is required.

Figure 10. Reanalysis of solution with soldier pile considering the weak plane (SF = 1.20)

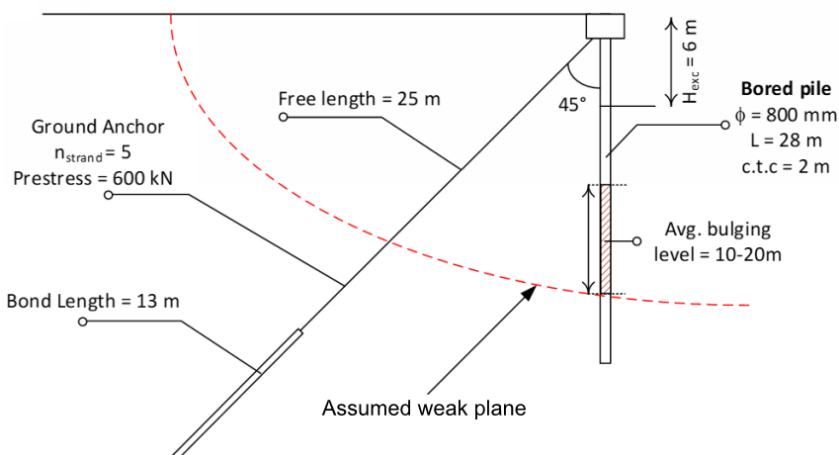
Figure 11. Details of ground anchor reinforcement

For the ground anchors to be effective, the ground anchors have to penetrate deeper than the weak plane, penetrating into the hard layer. Thus, the ground anchors length is chosen to be 38 m, with 25 m of free length (penetrating the weak plane), and bond length of 13 m. The ground anchors are to be installed at 45 degrees angle and a spacing of 4 m between anchors with 600 kN prestress are used. The details of the ground anchors are shown in Figure 11, and the finite element model is shown in Figure 12.

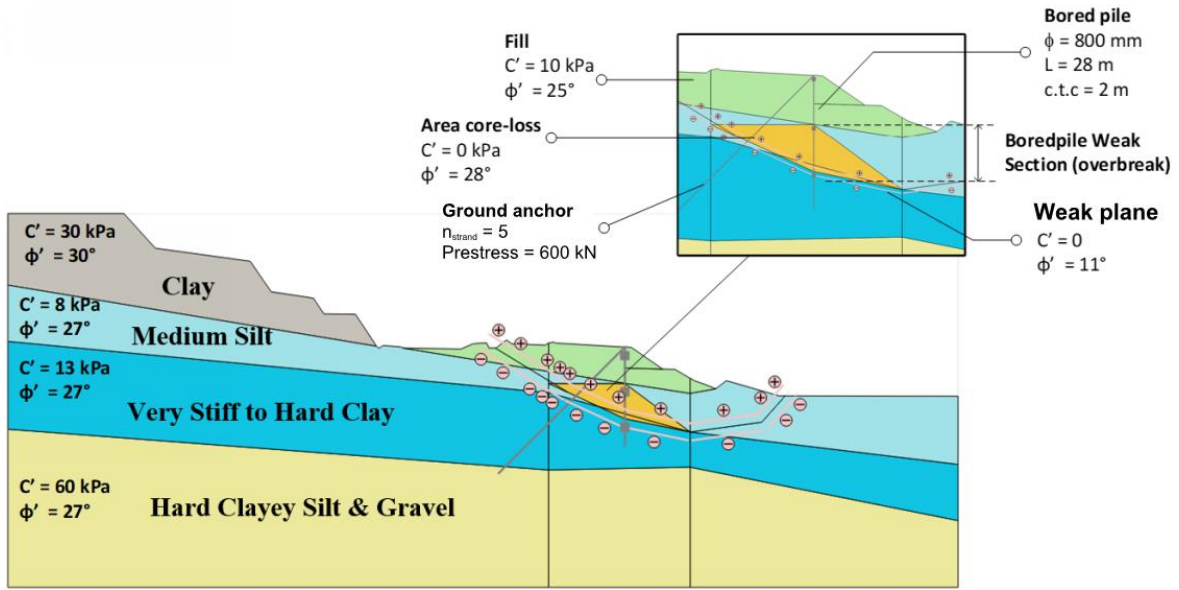
Figure 12. Plaxis 2D model of anchored bored piles

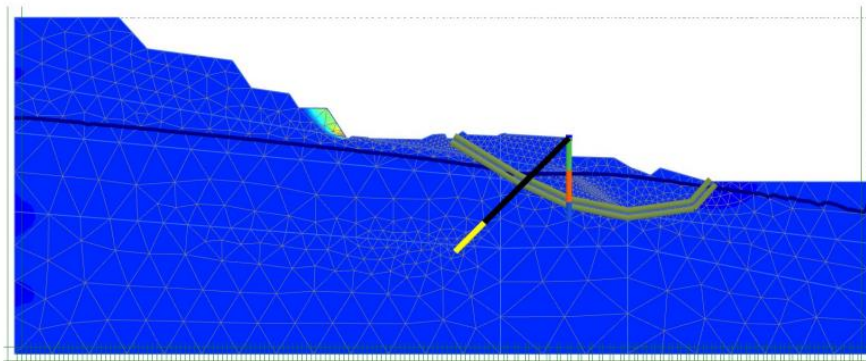
Figure 13. PLAXIS 2D output on bored piles reinforced with ground anchors (SF = 1.43)

The result of soldier piles with ground anchors is shown in Figure 13. From the result, it can be seen that the slip surface has moved out of the piled area, just like the initial design (Figure 4). Hence the factor of safety returned to 1.43. Only bored piles not socketed into the hard layers are reinforced with ground anchors, namely BP 17 to BP 45. Figure 14 shows the area reinforced by the ground anchors.

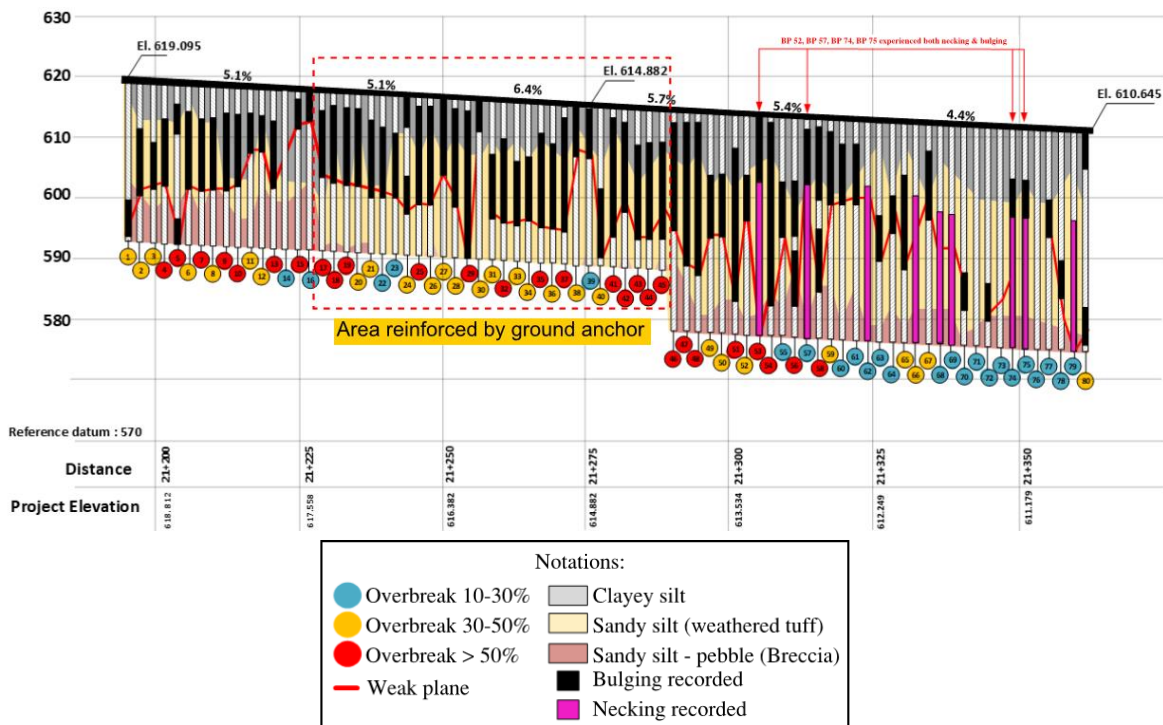
Figure 14. Section of bored piles reinforced using ground anchors
