Sheet Pile Failure Caused by Scouring and Sand Mining at Padang River Bank

Hansen Tananda^{1,*}, Andy Sugianto² and Paulus P. Rahardjo³

¹Geotechnical Engineer, PT. Geotechnical Engineering Consultant, Bandung, Indonesia; hansenananda91@gmail.com

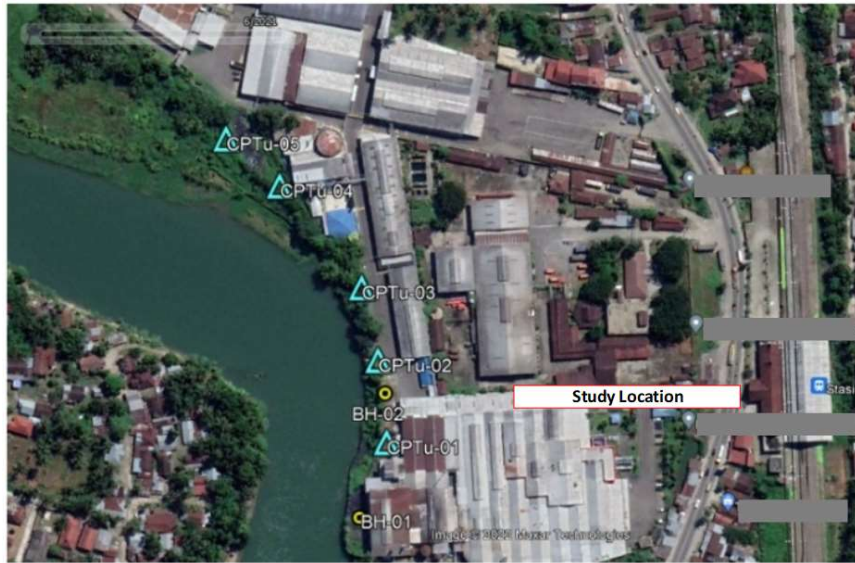
Figure 7. Latest soil investigation layout

The location of the soil investigation points in 2022 are focused on the area along the landslide or the movement of the steel sheet pile.

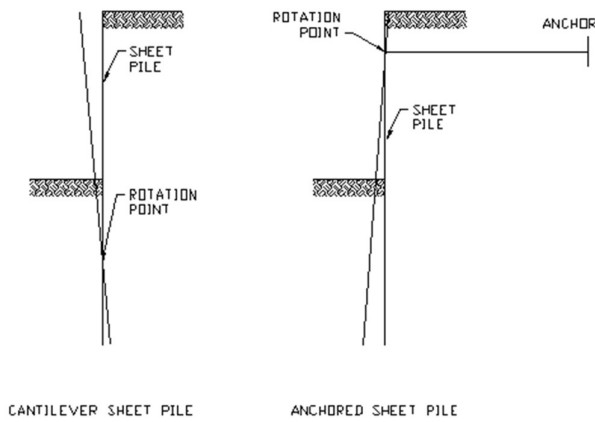
Figure 11. Commonly assumed failure mode of cantilever sheetpile

usually occurs gradually with reduced soil strength or with changes in geometric conditions such as steepness of a slope. Considering the actual site condition, it can be said that there are 2 sheet pile failure patterns as shown in the following Figure 11.

Based on site observation, the landslide mechanism that occurs is caused by the material behind the sheet pile being scoured so that the soil resistance is reduced. Referring to the technical drilling data that has been carried out, it can be seen that at the foot of the sheet pile, there is a layer of very soft soil, which can have an impact on the lack of resistance so that the sheet piles are unstable.

The scouring on the river bank across are thought to be repeated in the sheet pile area. This causes the soil behind the sheet pile to be washed and the sheet piles become free-standing resulting in a lack of passive resistance on the sheet pile due to scour along the sheet pile.

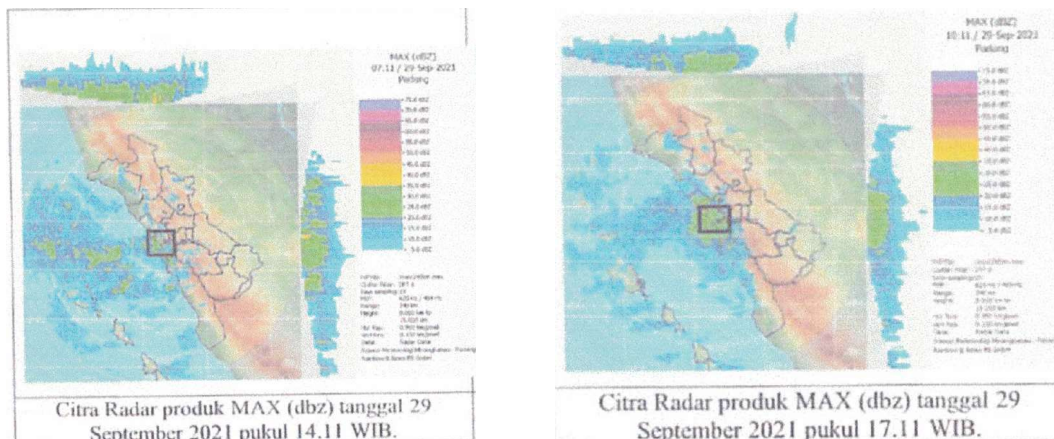
Figure 16. Rainfall Data BMKG

In the case of land movement that occurred on September 30 2021, there is data of rain conditions on September 29-30 2021 in the Batang Anai District area, Padang City obtained from the BMKG weather report. Based on MAX Weather Radar Imagery on September 29 2021, the maximum reflectivity value reaches 35 dBZ from noon to early morning (around 13.00 WIB to 04.00 WIB). Based on weather radar data for the CMAX product, cloud growth was observed to occur in water areas and move into the mainland of West Sumatra at 13.00 WIB with a reflectivity value of 30-40 dBZ indicating moderate intensity rain. Furthermore, it was observed that cloud growth continued to cover the Padang Pariaman area with a reflectivity of 40 dBZ until 22.00 WIB.

Based on radar imagery the reflectivity value only shows indications of moderate intensity rain, but this condition occurs continuously from day to night which causes the cumulative rainfall value to reach the category of extreme rain (> 150 mm/day). The total accumulated daily rainfall intensity, based on the Padang Pariaman Minangkabau Sarnet Station, reaches 250mm, which is included in the extreme rain category. This rainfall is a factor that greatly influences the condition of the flow pattern of the Batang Anai River which causes the river flow rate to become very heavy.

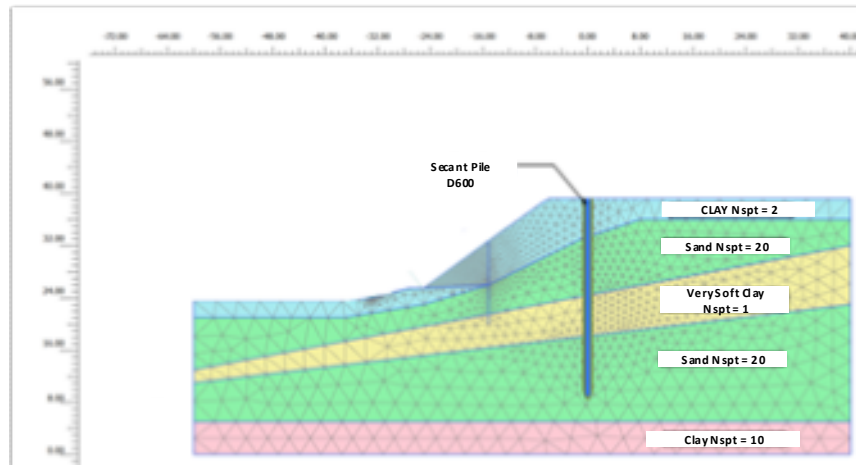
Figure 21. Soil model on Plaxis2D

Oo, et al (2013) and Matsui & San (1992) explained that the Finite Element Method uses the strength reduction technique by factoring the model parameters c and ϕ . The strength reduction factor is gradually increased until failure of the slope occurs. Modeling and analysis by Plaxis 2D program was carried out at the area which represent sheet pile condition that was deformed due to the main landslide event. The analysis was carried out by modeling the soil layers based on the closest drilling data, namely BH-1. Soil stratification is modeled as 5 layers as shown in Figure 21 below.

The initial slope analysis was carried out by modelling the existing condition of the slope where the factor of safety condition is 1.0. Back analysis is based on the cross section and the nearest soil investigation data. The results of the actual condition slope analysis using the help of the Plaxis 2D finite element program are shown in Figure 22. The shear strength reduction technique has a number

of advantages over the method of slices for slope stability analysis. Most importantly, the critical failure surface is found automatically (Dawson et al, 1999). The analysis results obtained that the factor of safety does not meet the allowable criteria, therefore reinforcement is needed.

The soil parameters from the back-analysis can be obtained with a residual friction angle as $\pm 20^\circ$. This value is used during the soil improvement process. The recommended reinforcement is to use secant pile D600 mm c.t.c 1.2 m. After installing the D600 mm ctc 1.2 m of Secant Pile, the slope stability safety factor is increased to more than 1.5 (Figure 23).
